Lorber Engineers

RE: Home Inspection
12345 XXXX St
San Diego, CA 92130

As you requested, we completed a limited structural and mechanical inspection of the above property on June XX, 201XX. This report presents the results of that inspection.

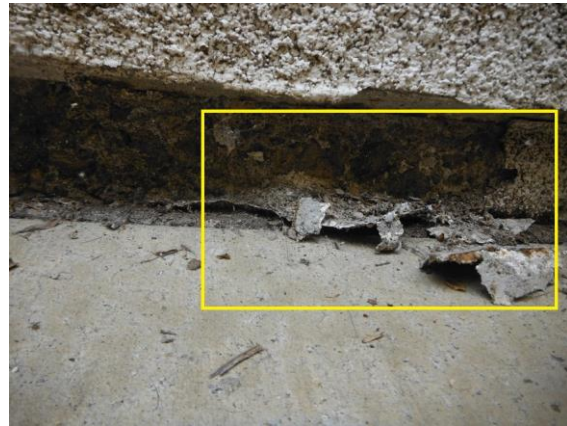
A stucco “smear” coat and/or heavy paint has been applied to the edge of the foundation which can obscure important cracks.

Direct, visible **foundation/structure appear intact and performing as intended.** The areas where we are able to view the edge of the foundation slab revealed no indicators of problems.

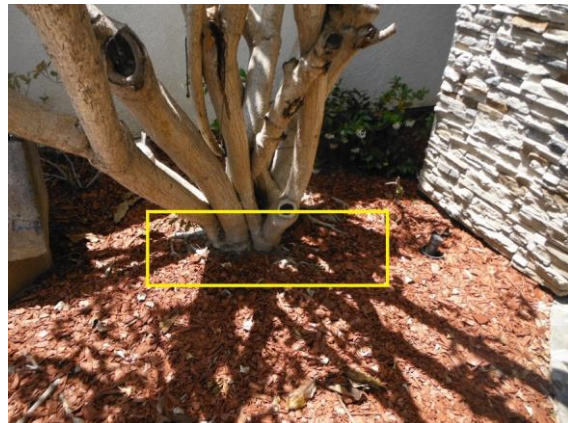
- Invasive tree root systems are present on the property near the foundation. As an advisory, some types of root systems are capable of causing structural damage.

Invasive tree root can also cause damage to main sewer line which runs to the street in front.

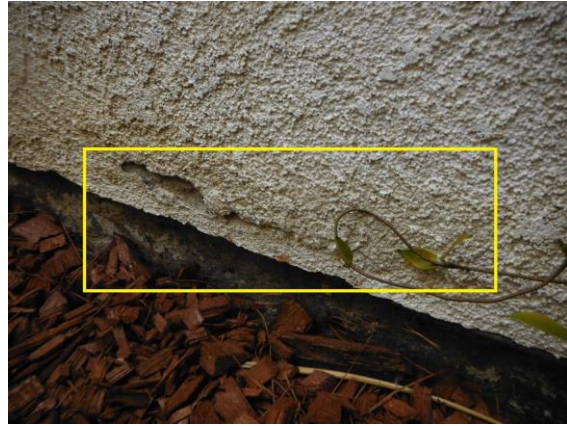
- There are indicators of irrigation system spray on the exterior walls; indicators include some rusted metal flashings (weep screeds) at the bottom of the stucco,

and some spot blistered paint/stucco

Re-direct spray as required as chronic wetness can cause finish and moisture barrier damage and other moisture problems.

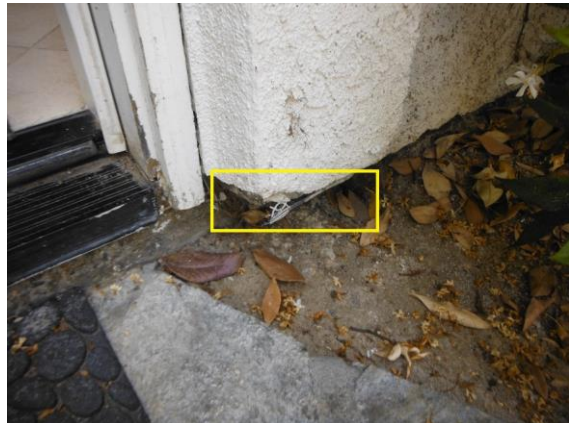
- There is some minor spot damage to the stucco at scattered locations.

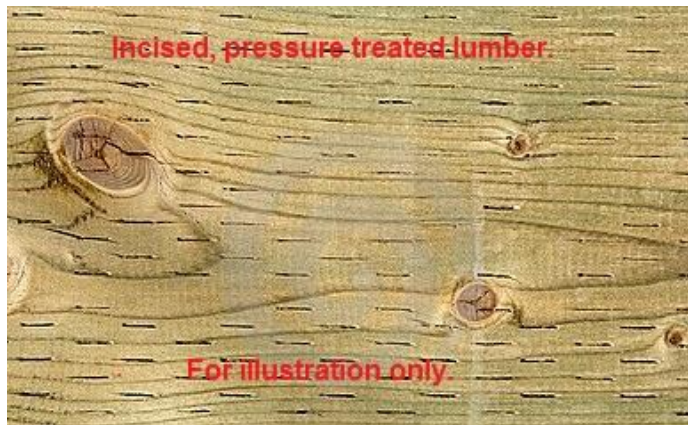
The ledger board is required to be of naturally disease resistant wood, e.g., redwood or pressure treated wood that could typically be identified by the incising (indents). We have no visual evidence that it meets either naturally disease resistant wood or pressure treated wood.

We recommend asking the seller to provide a stamped, engineered detail of how this ledger was attached that reflects the current visible conditions, and is of the proper size and composition. Otherwise, further evaluation is needed, before the release of contingency, to determine the exact conditions and if they are adequate

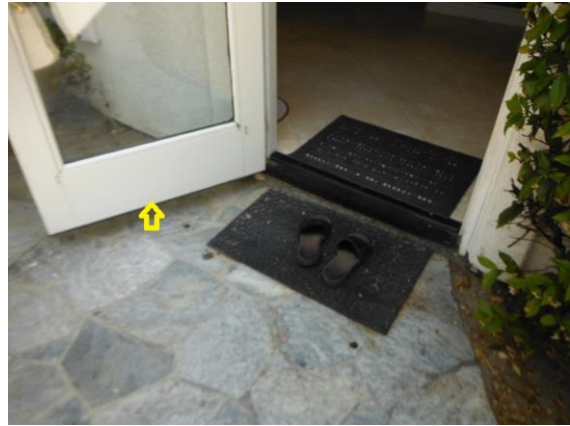
- Although a very common occurrence, the landings at the lower level exterior doors are non-compliant.

When an exterior door opens outward, there can only be a max 1" distance to the landing (distance between the top of the threshold and landing surface on the exterior). It's possible that these doors were all originally designed open inward but were altered during the actual construction.

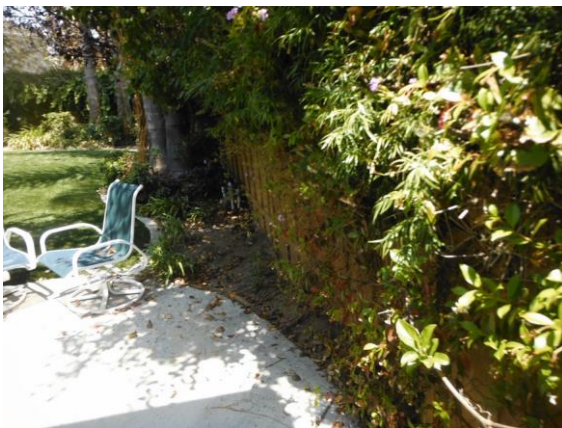
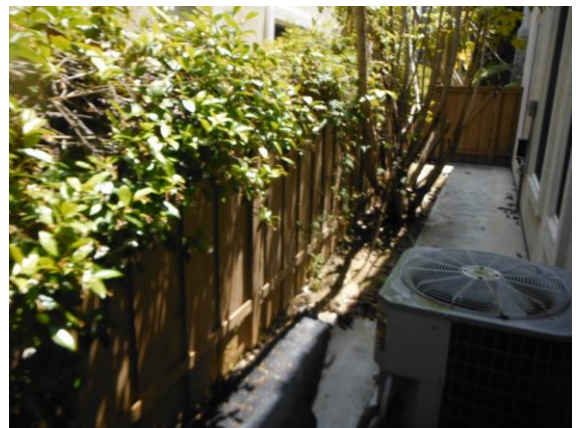
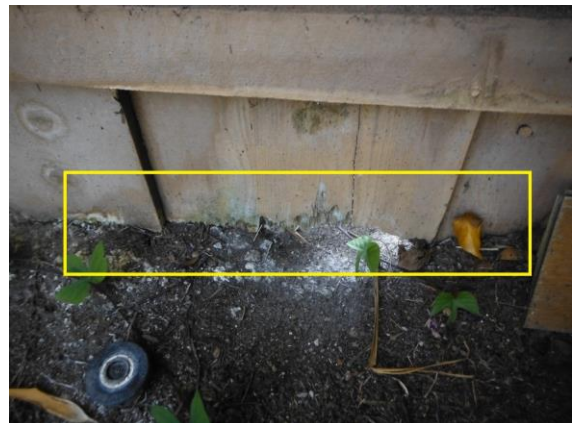
- Many sections of the fencing are not sturdy; likely indicates termite damage and/or rot of the fencing. Recommend consulting with your structural pest control contractor for further guidance.

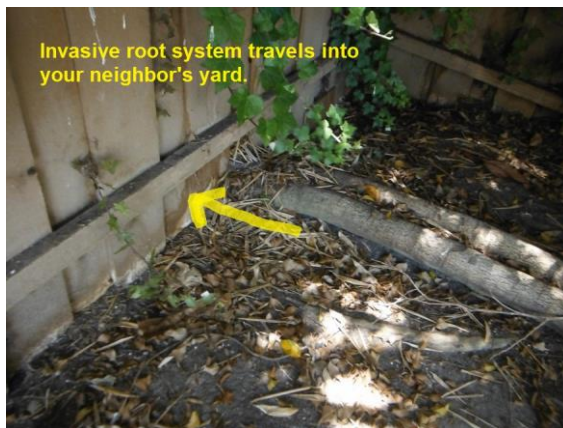
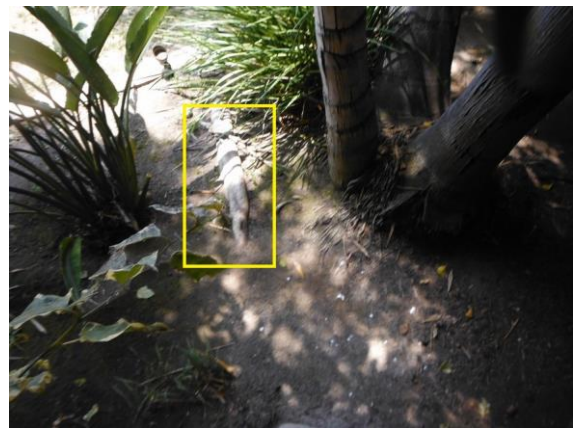
- Invasive tree roots are growing up against the fence with some roots traveling into your neighbor's yard.

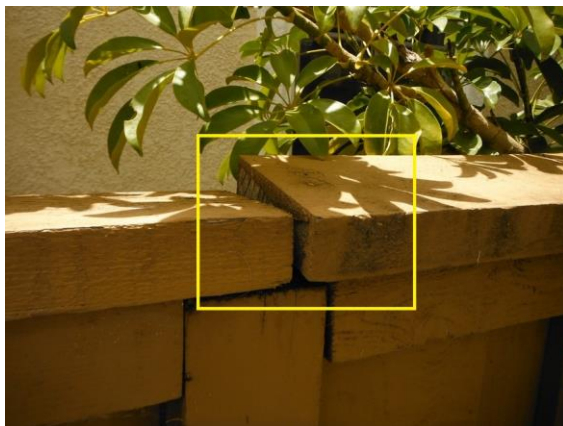
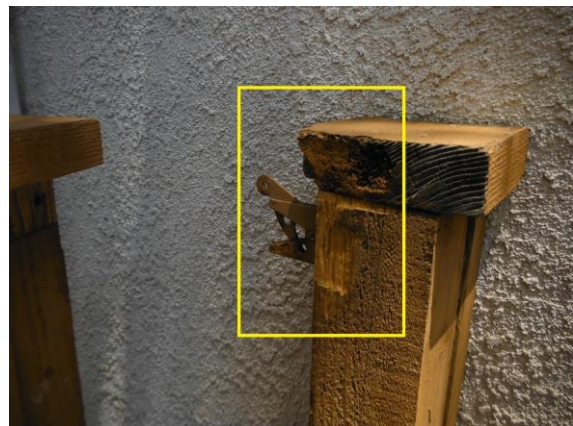
- There is some minor spot fence damage.

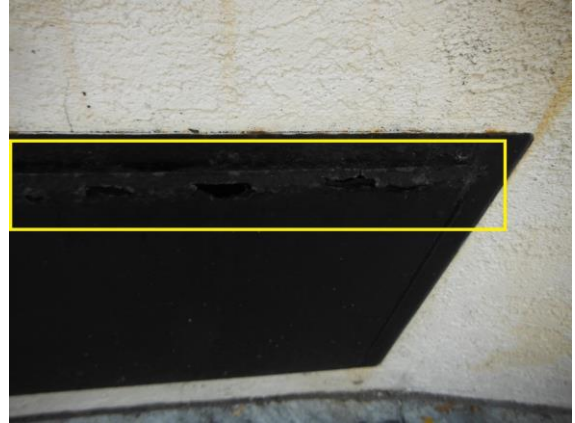
- The metal door and door opening frames are in corroded condition. The door latches are “frozen” tight.

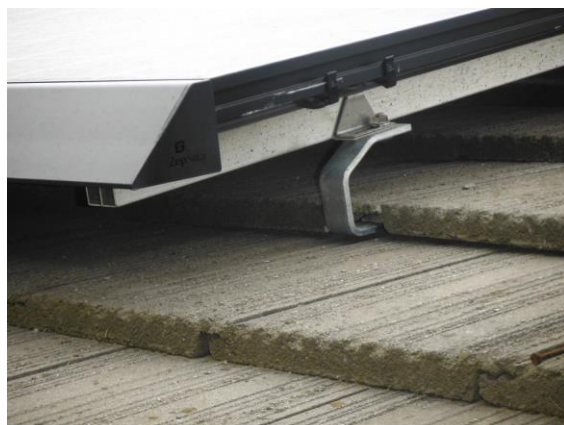
- A low profile concrete tile roof covering is installed.
- A concrete tile covering nominally has about a 30 year service life when new. Reportedly installed about 17 years ago, we estimate that it has about 13 years remaining (assuming no current shortcomings that would more rapidly deteriorate the moisture barrier).
- We did not walk on the roof covering because most was inaccessible. Consequently, it was inspected from ground/ladder and window vantage points.
- Some roofing discrepancies cannot be identified without walking the surfaces. **Some of the roofing cannot be seen at all, including areas obstructed by the solar collectors.**
- Only representative aspects of the visible roofing were inspected. Not a 100% roofing inspection.
- Solar collectors are installed on the roof. Many roof penetrations are required.

We assume that there was coordination between the installers and a roofer. No way to know if attachments are water tight/sealed/adequate. Coordination is essential to avoid the potential for leaks etc. Also condition of the tiles under the solar collectors is not visible/known. This system will have to be temporarily relocated from the roofing when this roofing is replaced.

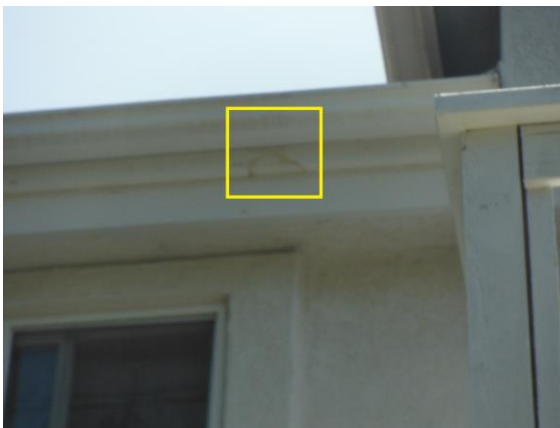
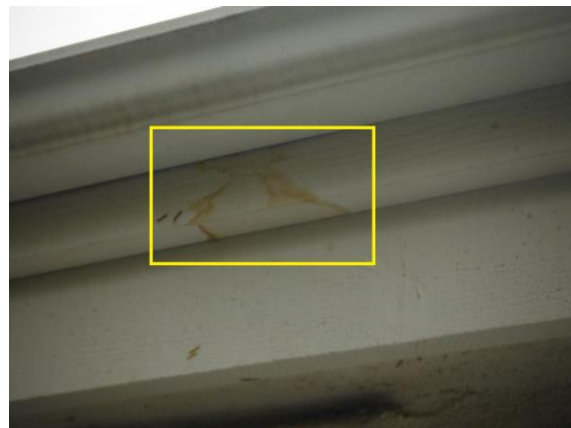
- There is some staining of the fascia on the west side.

While this most likely reflects water flow behind the gutter which reflects some gutter system shortcoming, we cannot rule out the possibility that water is getting under the tiles above this area and coming out at the bottom of the shadow board. We recommend that a licensed, competent roofer confirm the exact situation/conditions and make any recommendations for correction/repair ideally before the release of contingency.

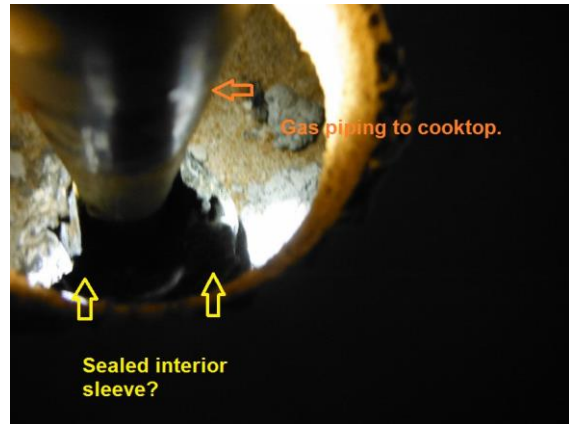
primarily because we could not locate the exterior vent. Further evaluation is needed to determine the exact condition.

Not having the piping sleeve vented to the exterior is a safety hazard. Deciding if its absence is a construction defect or would be considered an improvement would require further research. The seller may be able to provide further information, for example, if there had been a remodel from electric-to-gas cook top.

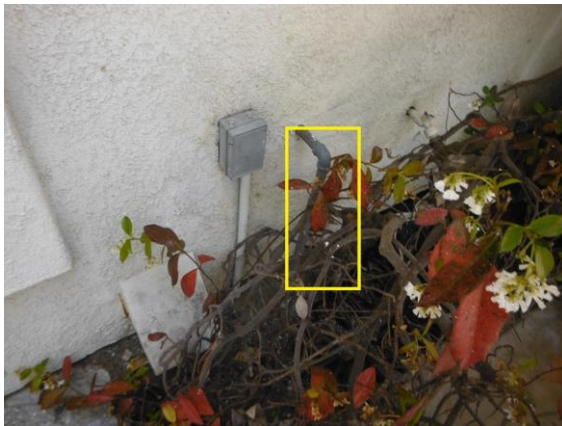
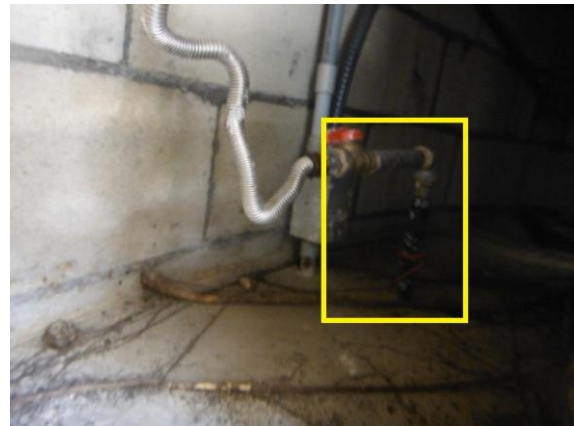
- Gas piping has likely been added after-market to serve the BBQ. Inspection by the local building inspection department would examine the type of piping used, depth of burial (as applies) and a 24 hour pressure test. We have no way to know the condition of the underground piping.

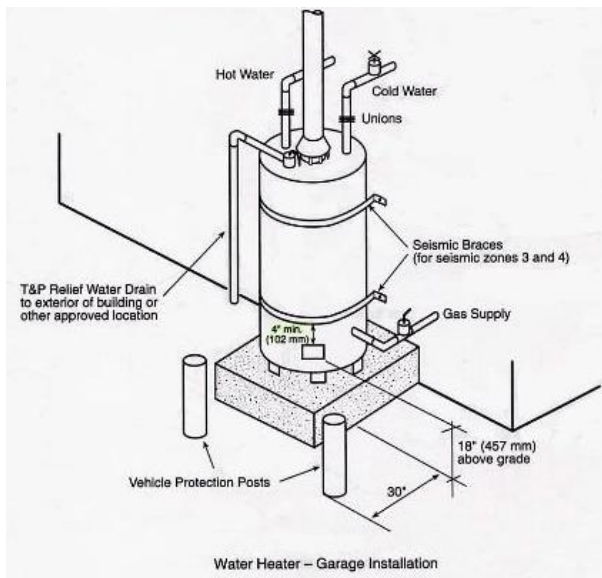
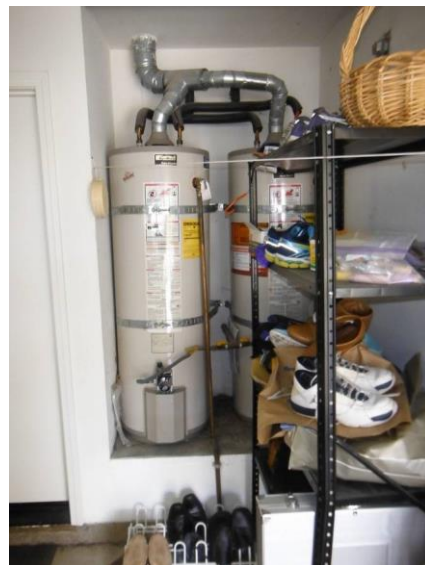
- 2. 50 gallon, gas-fired heater are installed in the garage.

- The water heaters have about a 7-10 year service life; they appear to be the original - 17 years old. The water heaters are well beyond the end of their expected service lives; can fail at any time.

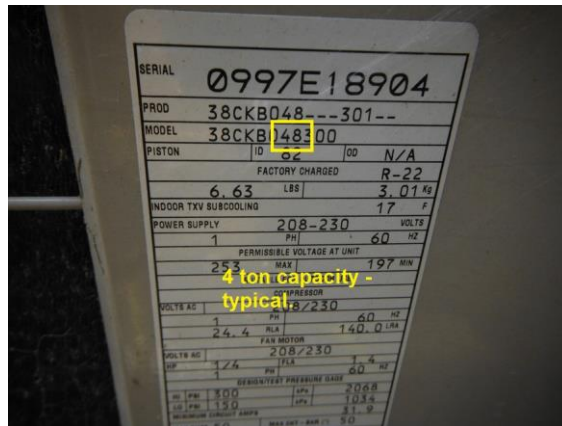
- 8 tons of cooling are installed (2 x 4 tons).

Using a rule of thumb, this is just barely adequate if not undersized to serve a 4000 + square foot home with vaulted ceilings and may not provide the cooling desired on the most challenging days (high temperature and high humidity).

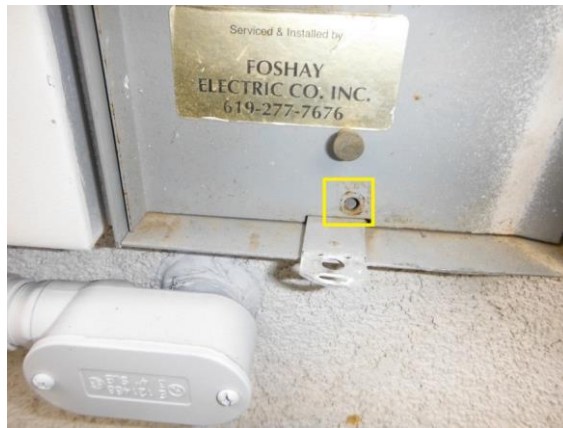
The panel attachment screw is missing; recommend installing a manufacturer approved screw (one not too long and without a sharp point) for safety.

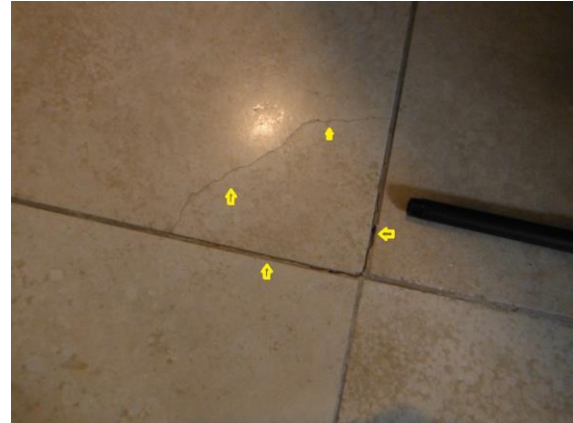
- We located a couple cracked floor tiles in the living room and kitchen. Conditions indicate that they are from impact damage, but we cannot categorically rule out, at least, an underlying drying shrinkage slab crack without removing the tile. All concrete cracks to some degree; some cracks are important, most are not.

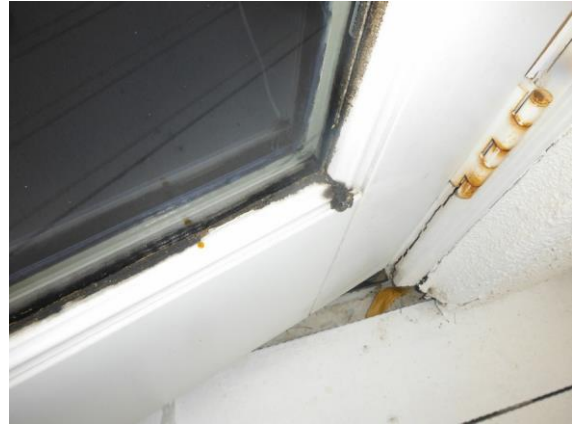
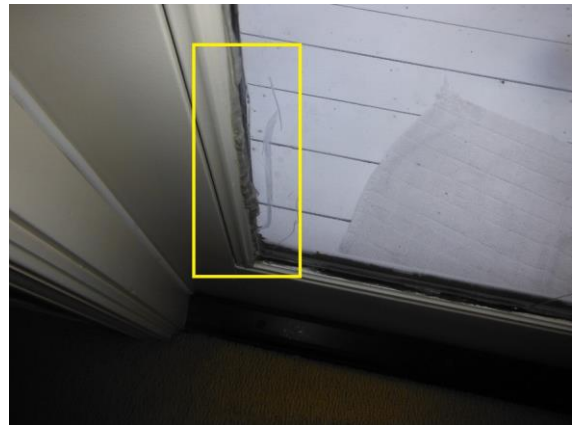
- There is excessive and unsightly sealant present at some of the exterior doors which contain thermopane glazing.

It's possible that the thermopane glazing was replaced in these doors and was not reinstalled well. Our concern is that water will be able to get behind the millwork/trim and eventually damage the doors.

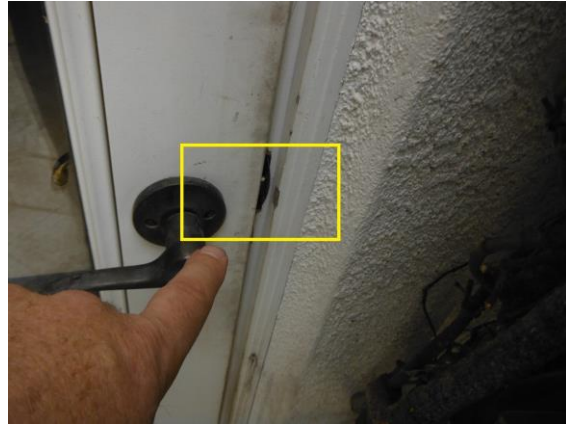
- The exterior door to the kitchen does not latch; you have to rely on the dead bolt.

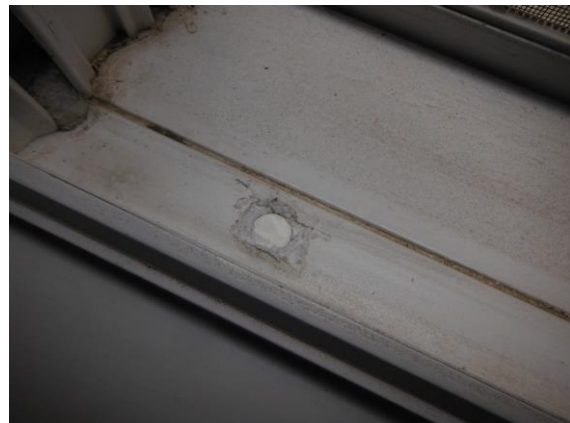
- There appears to be some alteration of window frames to accommodate a security system wires. Some of the plugs have actually popped up.

We cannot verify that these alterations are watertight. We recommend sealing/ caulking any holes/openings.

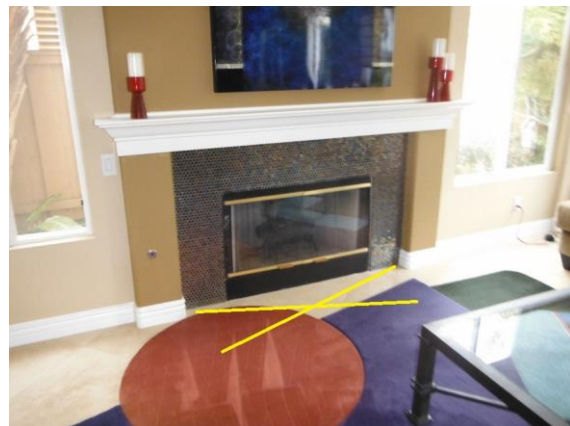
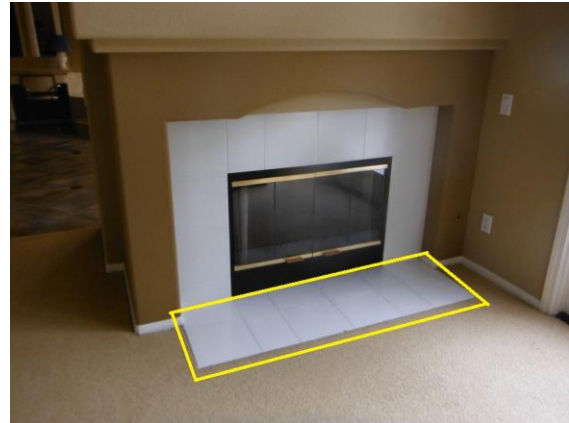
*** The hearth extensions have been removed likely during the aftermarket revision of the flooring around the fireplaces. Currently, there is no distinction between the hearth and flooring as required. This is a potential fire hazard because high heat can radiate to the floor immediately in front of the fireplace. Keep combustibles away from extension (area in front of fireplace) until corrected.**

* The fireplaces show some sooting of the artificial logs and refractory panels. Sooting indicates incomplete gas combustion. One result of incomplete combustion is the formation of, at least, a small amount of carbon monoxide gas. Recommend the gas log set be examined to assure proper burn/combustion.

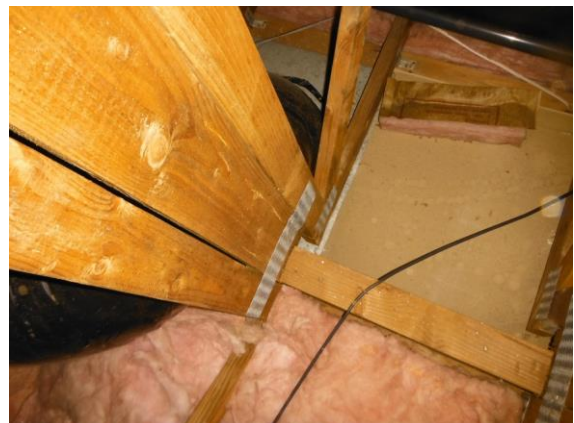
- A few insulation batts are out of place or missing.

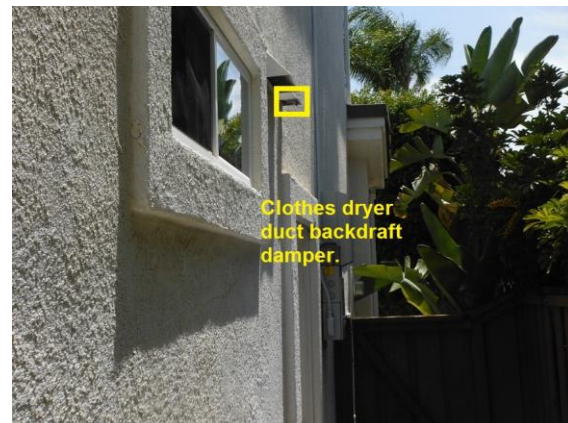
- **The clothes dryer duct to the exterior appears to exceed length limitations. A dryer vent cannot exceed 14 feet in total length when 2, 90 degree bends are involved. Recommend periodic cleaning of the lint from the duct for fire safety and dryer efficiency.**

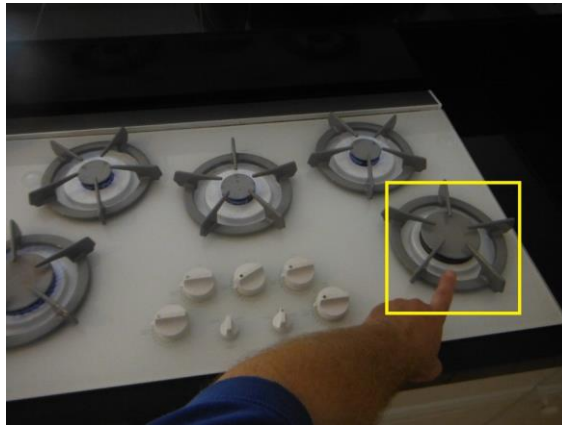
- The right-front gas burner did not light up; suggesting the need for, at least, maintenance. We recommend, at least, getting a satisfactory demonstration. An appliance contractor service call may be warranted.

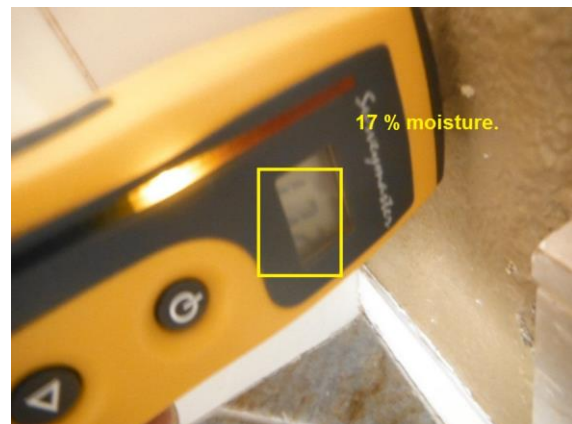
- There is minor spot drywall damage and slightly elevated moisture readings (17%) on the lower exterior wall at the shower.

The “leak mechanism(s)” or elevated moisture readings cannot be definitively known in the course of a home inspection; there are various possible causes.

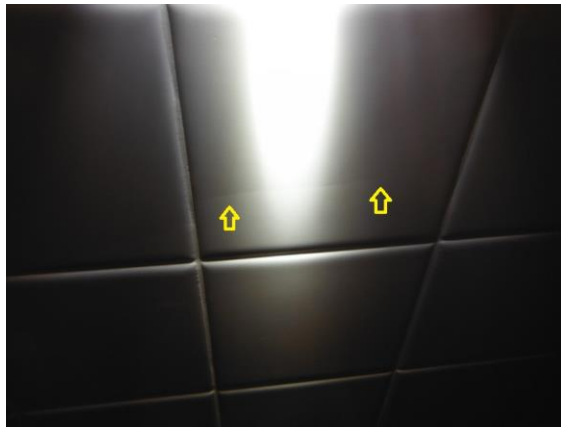
Indent cracks, typically, indicate some workmanship errors with installation of subsurface materials, for example, failure to properly tape a joint between two sections of backer board (water proofing board) or differential drying shrinkage where there are different thicknesses of the mortar/brown coat/adhesive applied behind the wall for the purpose of attaching the tile to the backer board.
