Lorber Engineers

RE: Home Inspection
12345 XXXX St
San Diego, CA 92130

As you requested, we completed a limited structural and mechanical inspection of the above property on June XX, 201XX. This report presents the results of that inspection.

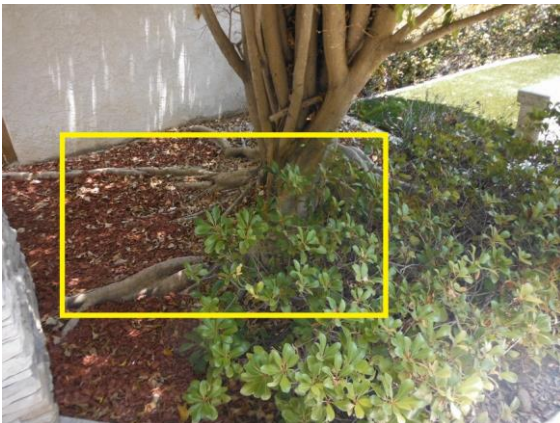
- Invasive tree root systems are present on the property near the foundation. As an advisory, some types of root systems are capable of causing structural damage.

Invasive tree root can also cause damage to main sewer line which runs to the street in front.

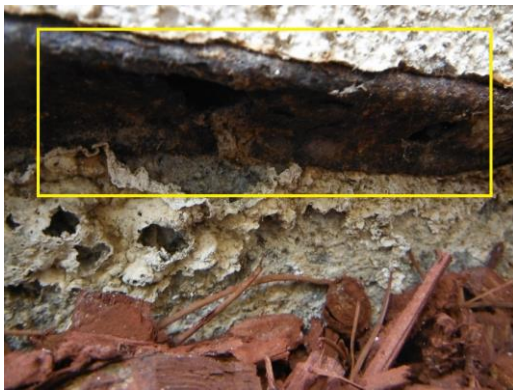
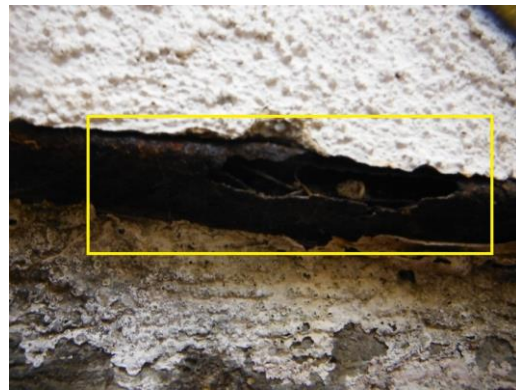
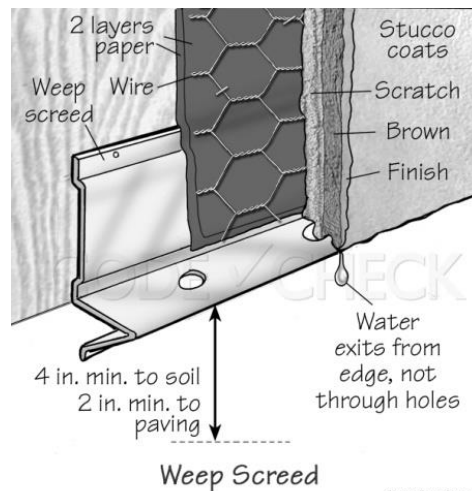
- There are indicators of irrigation system spray on the exterior walls; indicators include some rusted metal flashings (weep screeds) at the bottom of the stucco,

Re-direct spray as required as chronic wetness can cause finish and moisture barrier damage and other moisture problems.

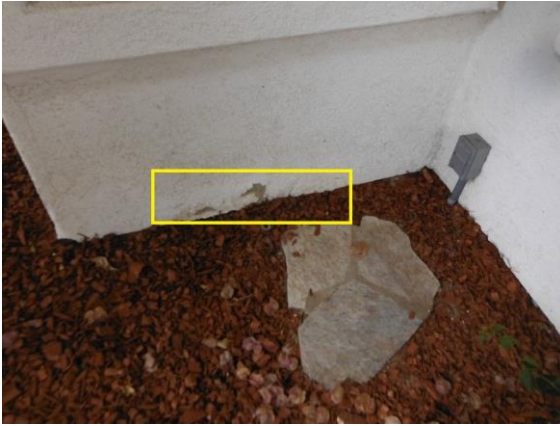
and some spot blistered paint/stucco

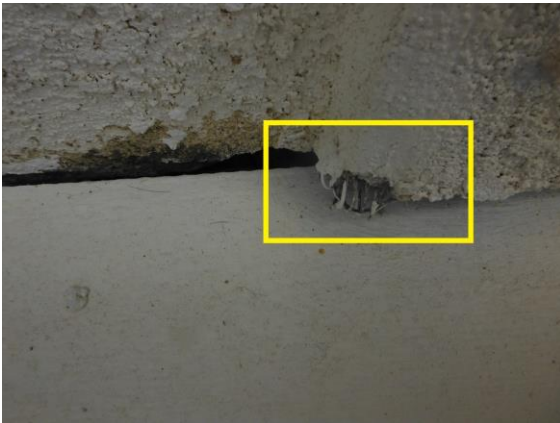
- There is some minor spot damage to the stucco at scattered locations.

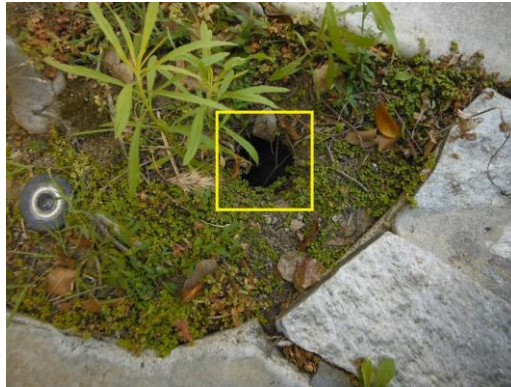
- At least 1 area drain is missing a drain cover in front. The drain cover should be replaced to help prevent debris from clogging the subterranean piping to the street.

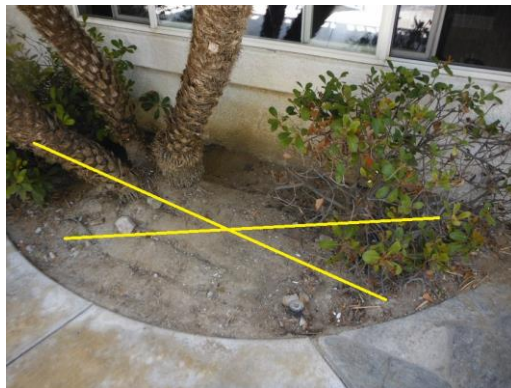
- Not all planting beds around the foundation are served by area drains.

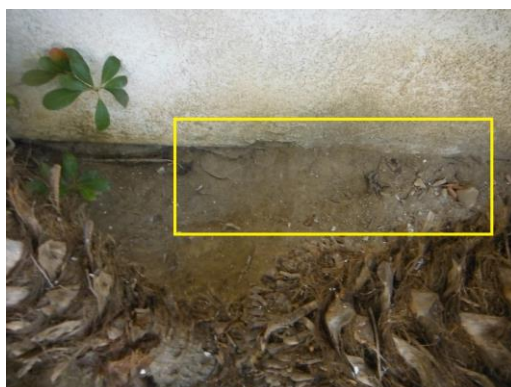
- There is some soil piled above the bottom of the stucco wall/metal weep screed in back; likely caused by a pet. We recommend getting clearance.

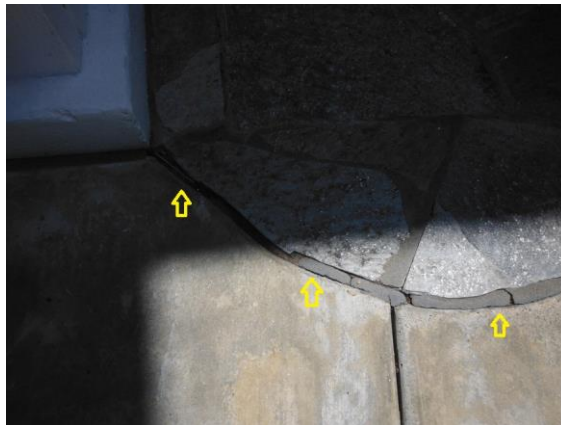
- Some of the joint sealant is deteriorated or missing in back. We recommend refreshing the sealant because it maintains the capability of the joint to expand and contract which helps prevent cracking of the hardscapes. Joints clogged with debris prevents the expansion and contraction.

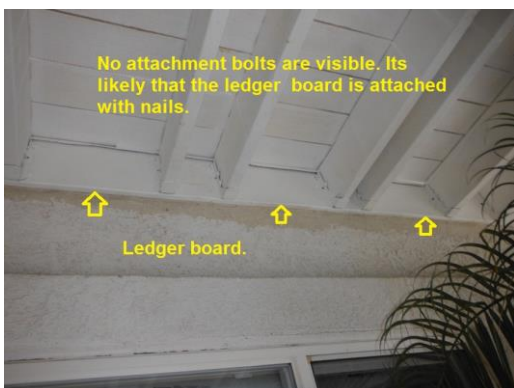
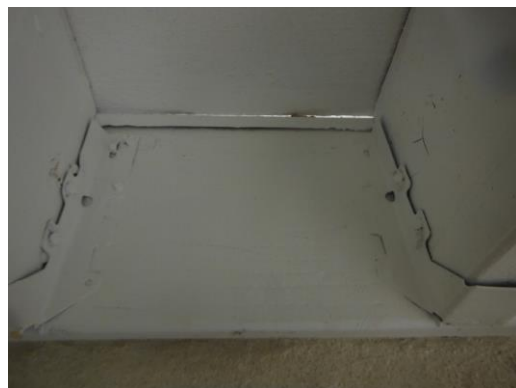
- We could not identify the method of attachment of the ledger board. This is the single most critical deck load path connection detail.

No lag screws or bolts were visible and we suspect that the ledger is nailed in place.

Ledger board attachment with nails is prohibited because they are subject to withdrawal.

We recommend asking the seller to provide a stamped, engineered detail of how this ledger was attached that reflects the current visible conditions, and is of the proper size and composition. Otherwise, further evaluation is needed, before the release of contingency, to determine the exact conditions and if they are adequate

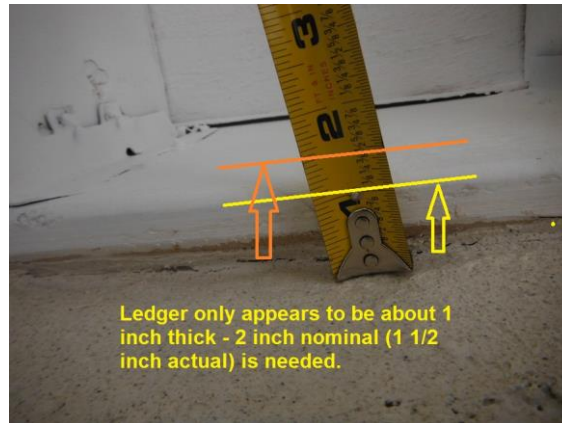
The thickness of the ledger is in question. A 1 inch actual thickness appears to be installed with 1 ½ inch (2 inch nominal) required.

The ledger board is required to be of naturally disease resistant wood, e.g., redwood or pressure treated wood that could typically be identified by the incising (indents). We have no visual evidence that it meets either naturally disease resistant wood or pressure treated wood.

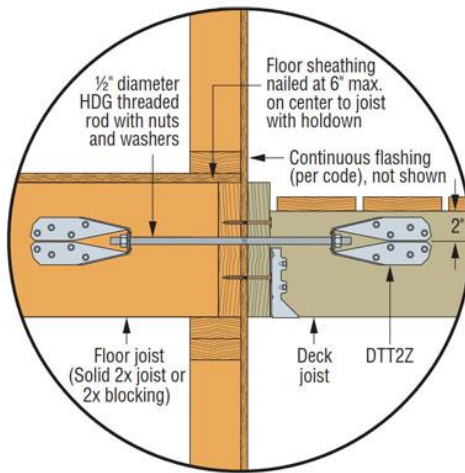
- Decks constructed since 2011 are required to include “ tension ties” to help the deck withstand lateral/earthquake loads. No tension ties are present. If not required when the deck was constructed, then, as an improvement, we recommend that you consider adding them in the future.

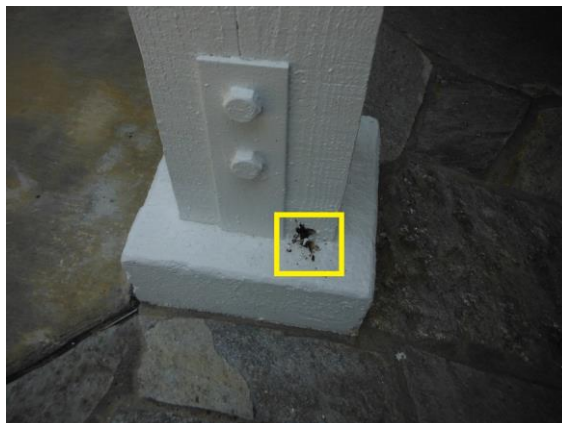
- There appear to be some spots of wood rot. Recommend consulting your structural pest control contractor for further guidance.

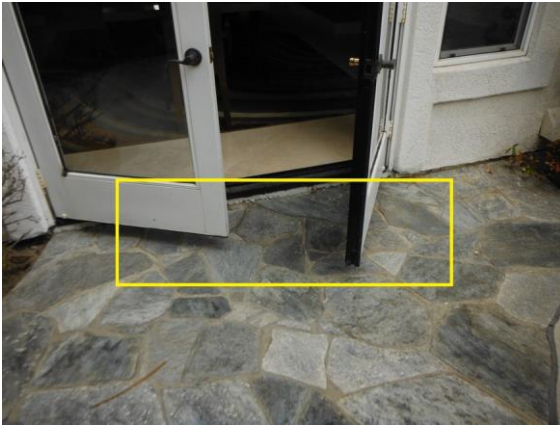
- Although a very common occurrence, the landings at the lower level exterior doors are non-compliant.

When an exterior door opens outward, there can only be a max 1" distance to the landing (distance between the top of the threshold and landing surface on the exterior). It's possible that these doors were all originally designed open inward but were altered during the actual construction.

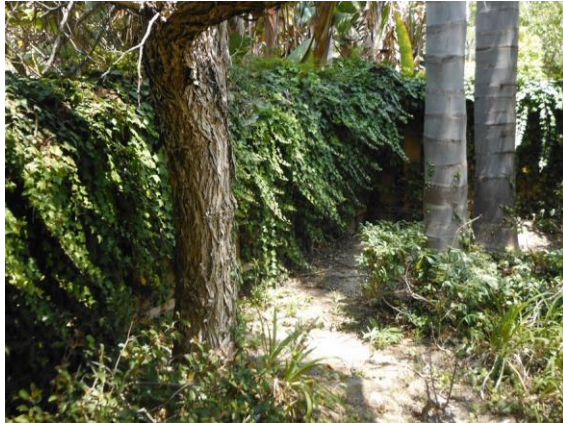
- Some of the fencing is overgrown by heavy vegetation and was not inspected. The heavy vegetation could be causing some damage.

- Much of the wood fencing appears older; fair to poor condition.

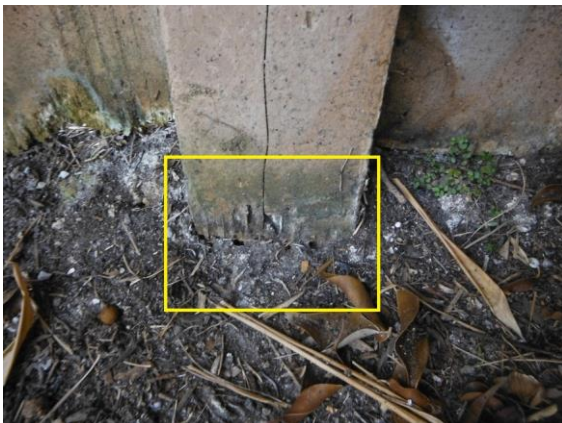
- Many sections of the fencing are not sturdy; likely indicates termite damage and/or rot of the fencing. Recommend consulting with your structural pest control contractor for further guidance.

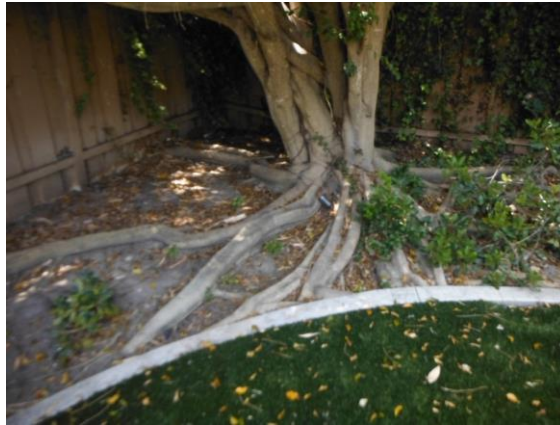
- Invasive tree roots are growing up against the fence with some roots traveling into your neighbor's yard.

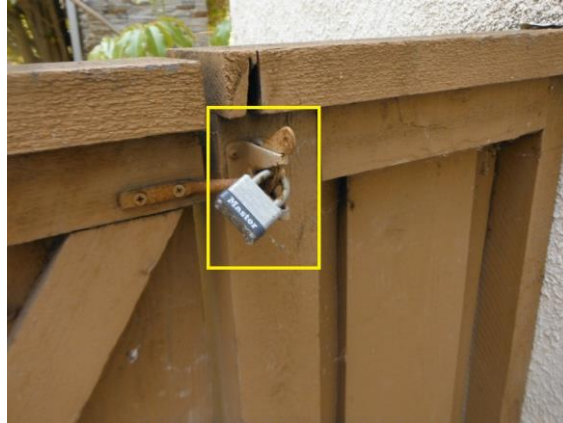
- The north side yard gate was padlocked and was not tested.

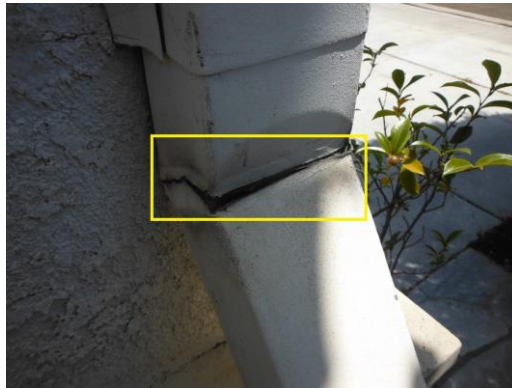
- The gutters contain some sediment and light debris; recommend cleaning and maintaining.
- There is, at least, 1 loose connection.

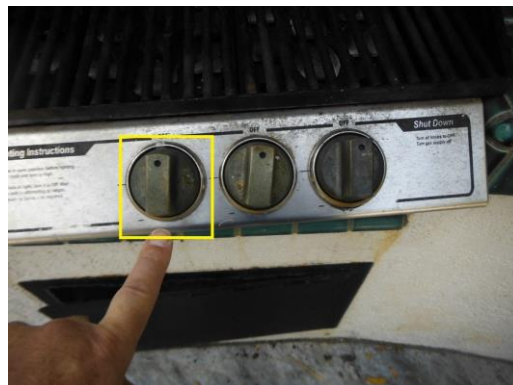
- The burners could only be lit from the left-hand control handle. The instructions indicate that all control handles can light their associated burner. Recommend getting a satisfactory demonstration for the close of escrow.

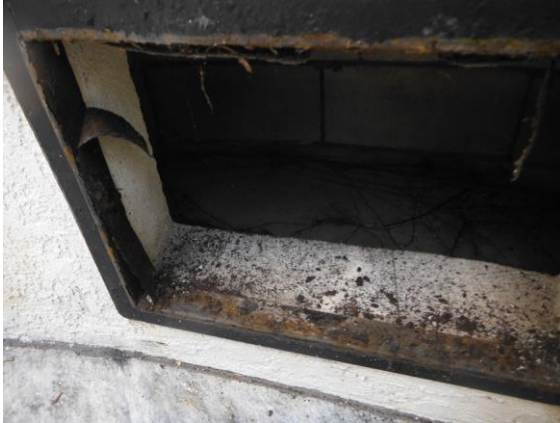
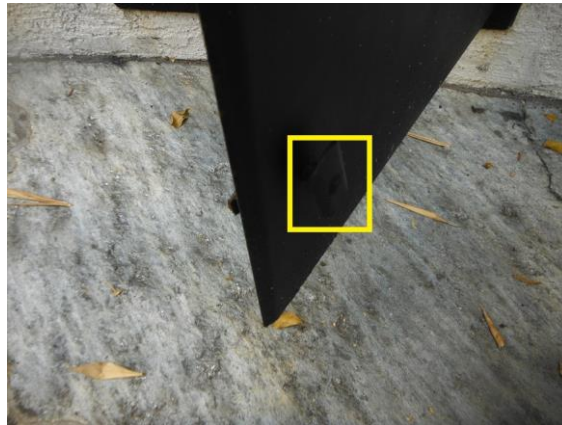
- The metal door and door opening frames are in corroded condition. The door latches are “frozen” tight.

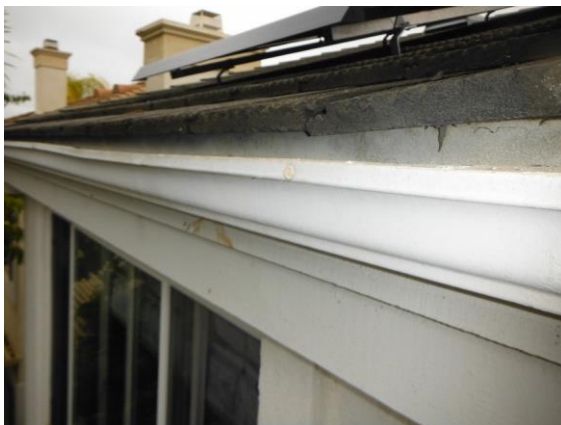
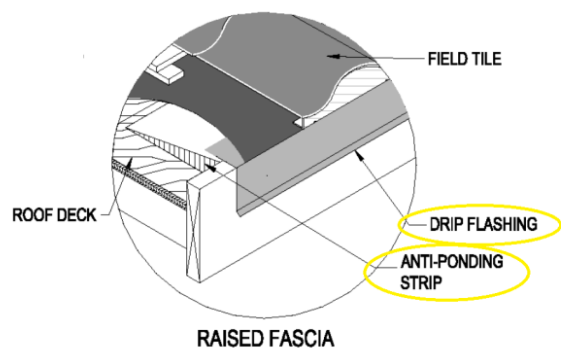
- Based on the eave “configuration” (fascia, booster/ shadow boards etc) its likely that there is a low area behind and all along the booster/shadow board and no anti-ponding strips installed.

Without the anti-ponding strips, the roofing paper sags behind fascia/shadow board and can expose the edge of the plywood roof sheathing, fascia and any decorative wood trim.

Any water that gets below the tiles can get trapped behind the fascia/shadow board and eventually deteriorate the moisture barrier leading to wood rot of the eave etc.

No metal drip edge is installed as would be required with newer roofing. The metal drip edge helps prevent water damage/wood rot at the eave.

As an improvement, we recommend that you consider making these corrections to help roofing extend service life or , at least, when you next reroof.

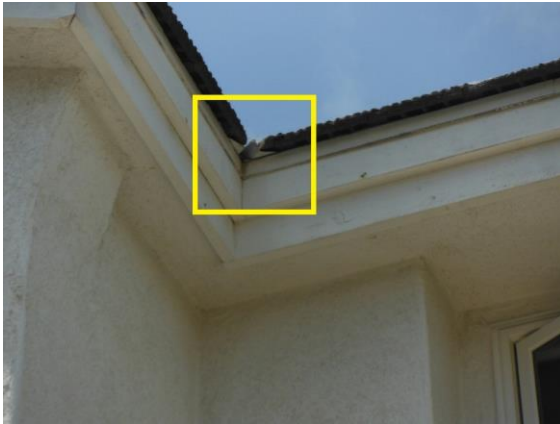
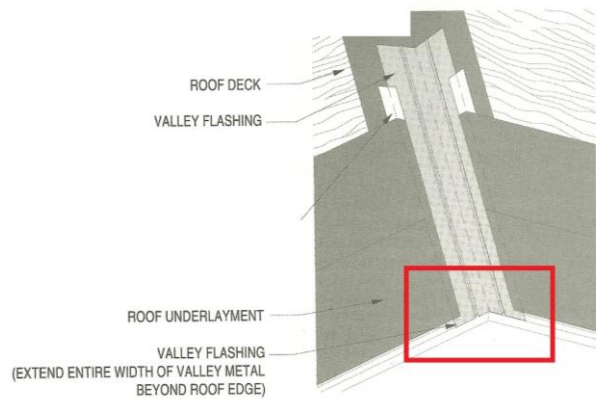
While very common, there appears to be improper termination of the valley flashing. The metal flashing doesn't appear wide enough at valley terminations which in turn exposes some of the moisture barrier to water flowing down the valley.

A metal drip edge would correct this situation.

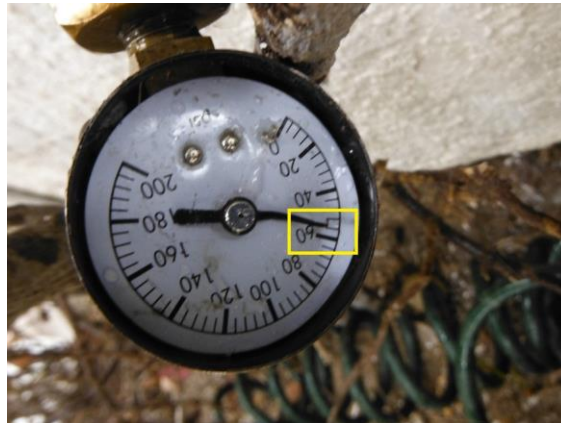
The water pressure was measured at the main service point as 55 psi, after being reduced by a pressure regulator. This pressure is adequate. The maximum recommended water pressure in a home is 80 psi and the minimum is 30 psi.

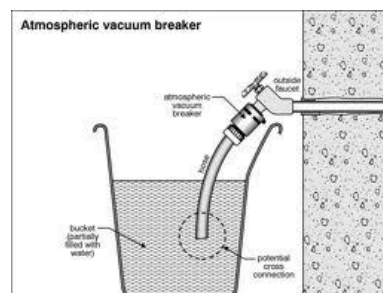
- Vacuum breakers are not installed at the hose bibbs as currently required. Vacuum breakers prevent the possible mixing of drinking and gray water, possible, for example, if the end of a garden hose were left in a bucket full of water. Adding a vacuum breaker is a simple, inexpensive task.

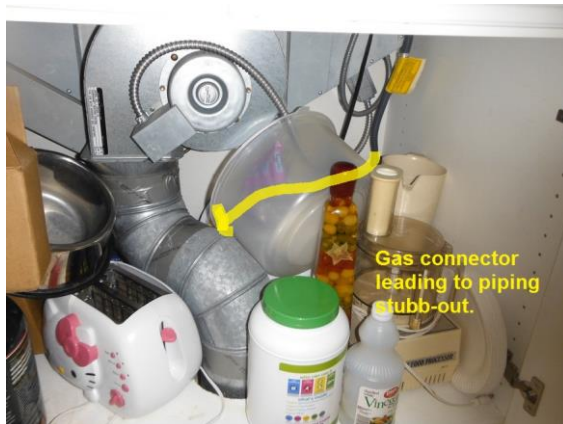
- Since about 1992, gas piping installed under the foundation slab to the kitchen island to serve the cooktop, has to be installed in a pipe sleeve that is sealed on the interior end and properly vented to the outside on the other end. This will help prevent a potentially dangerous buildup of gas below the slab in the event of a gas piping leak. We were unable to definitively determine if the sleeve is installed

primarily because we could not locate the exterior vent. Further evaluation is needed to determine the exact condition.

The interior sealed conduit appears to be present.

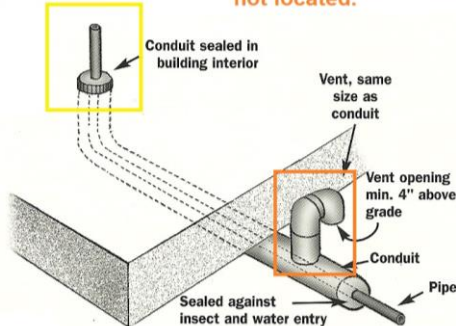
Exterior vent was not located.

Not having the piping sleeve vented to the exterior is a safety hazard. Deciding if its absence is a construction defect or would be considered an improvement would require further research. The seller may be able to provide further information, for example, if there had been a remodel from electric-to-gas cook top.

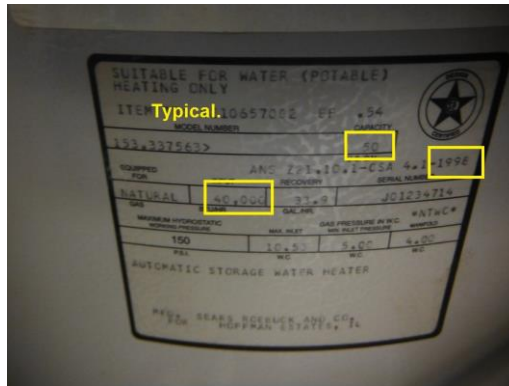
- The water heaters have about a 7-10 year service life; they appear to be the original - 17 years old. The water heaters are well beyond the end of their expected service lives; can fail at any time.

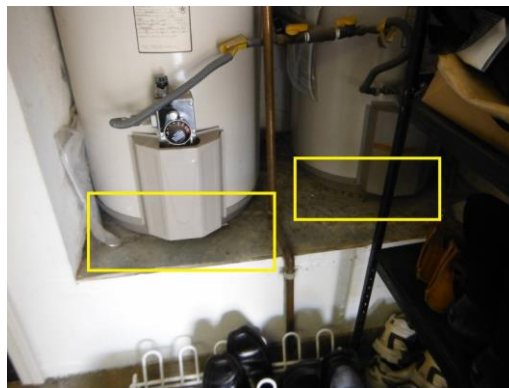
- No catch pans and drains to the exterior are installed as currently required. This common omission can lead to flooding/damage to finishes if/when the tank fails. Recommend installing these features when you next replace the heaters.

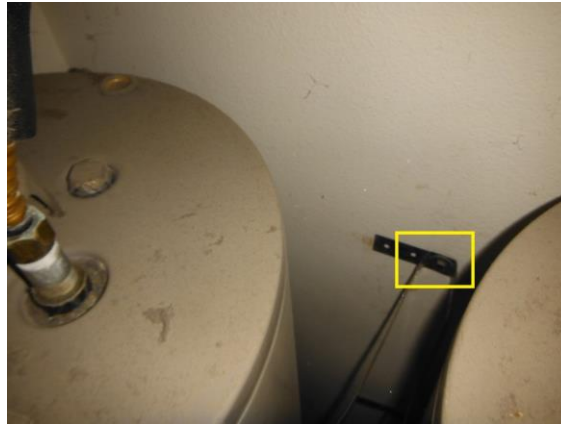
- Each tank should be strapped separately – 2 straps, 4 total points of attachment to handle the weight of a full water heater – 8 total points of attachment for 2 tanks. Right now, 2 of the lag screws serve strapping for both tanks thereby reducing the total number of attachments to 6. Recommend making the strapping correction at least when you next replace the heaters.

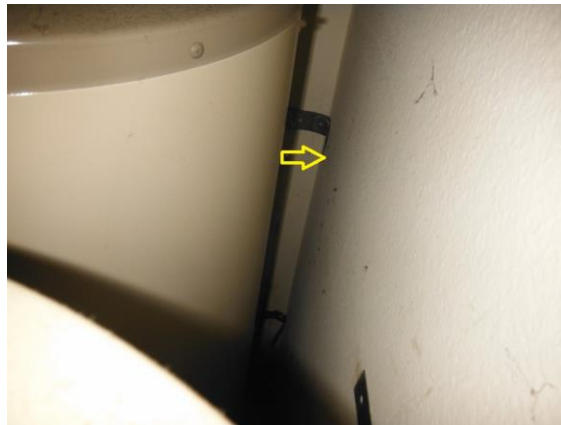
- The left-hand water heater is strapped, however, the tank isn't flush to the wall and can potentially rock backwards/sideways. Recommend blocking/ bracing the water heater at least when you next replace the heaters.

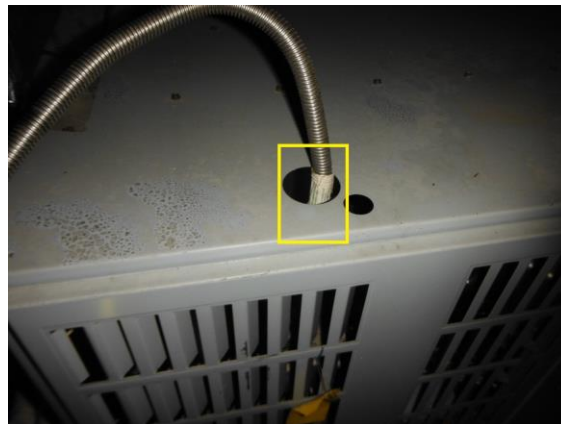
- The flexible gas connectors extend through furnace casing; this is no longer allowed. Aim is to prevent damage to the gas connector in case of earthquake movement etc. We recommend correcting, at least, the next furnace replacement.

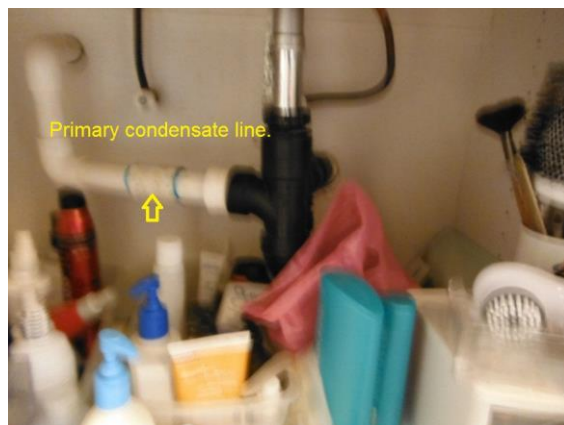
- Primary condensate drain termination point is located under the master bathroom sink. This is an appropriate location.

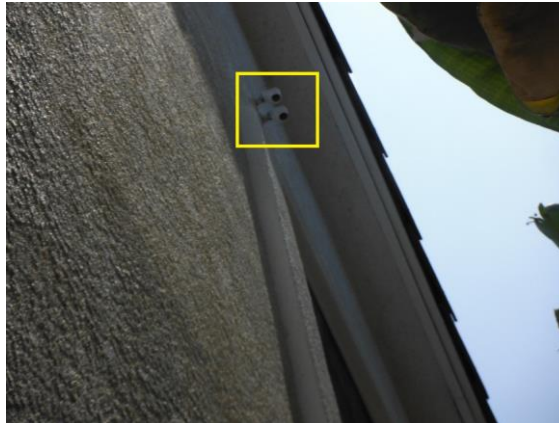
- The 2nd condensate drain terminations are stubbed out in the upper south exterior. This is an appropriate location. Any water coming out of these terminations would signal a primary drain piping clog warranting a service call.

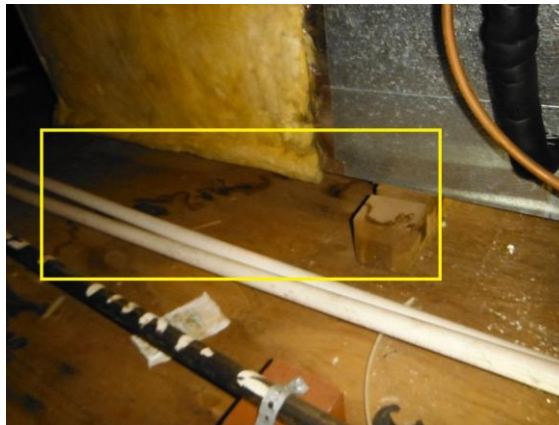
- There are stains on the furnace platform in the attic. The exact source is unknown but the primary source is sweating form the air conditioning system refrigerant lines or possibly condensate line leaks. An electronic detector indicates a normal level of moisture present at this time, however, this reading is a snapshot in time and not a comprehensive test for leaks. Recommend monitori

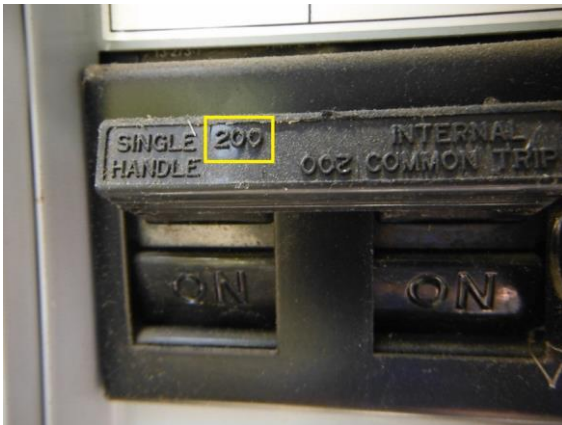
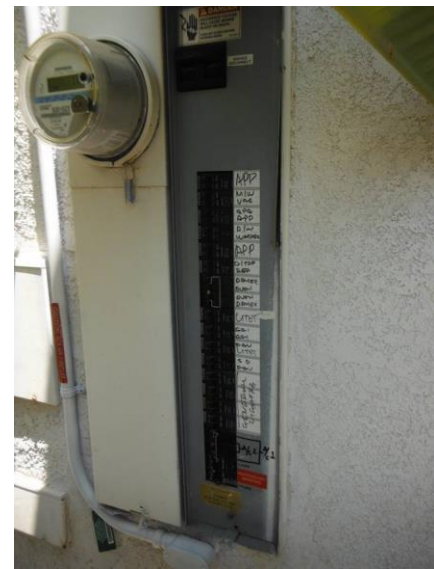
A 200 ampere panel installed; this size is adequate.

The panel attachment screw is missing; recommend installing a manufacturer approved screw (one not too long and without a sharp point) for safety.

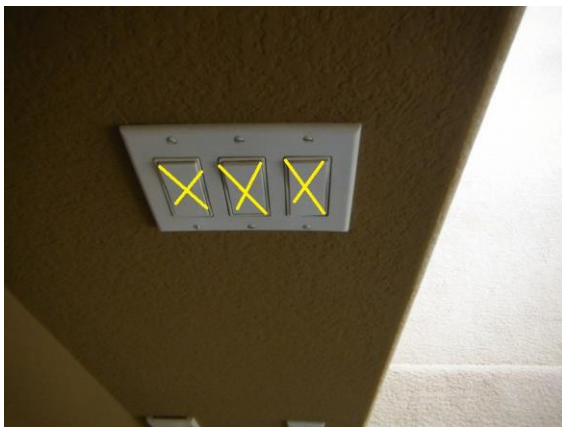
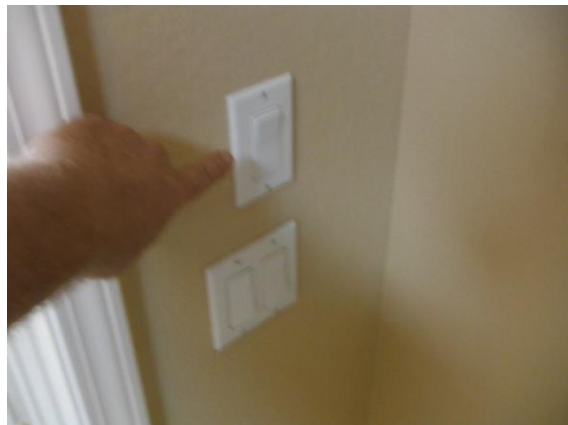
- A few switches, at various interior locations, do not appear to operate anything. Get demonstration of switches/switch controlled outlets by time of final walk-through.

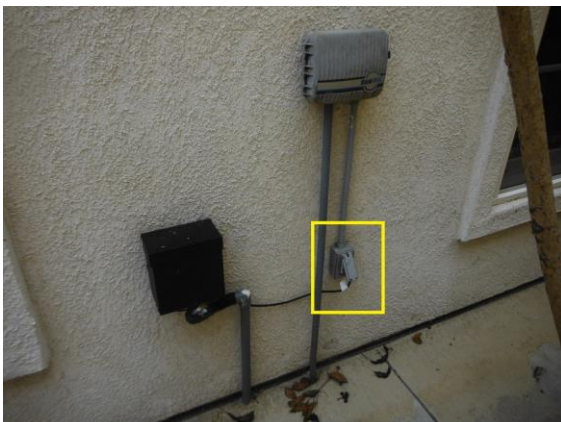
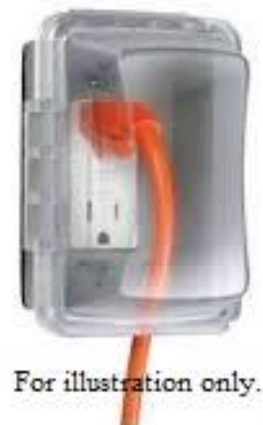
- Add weather tight covers to exterior receptacles with permanent equipment connected. Includes, but may not be limited to, receptacles serving the irrigations system and low voltage lighting controllers on the exterior.

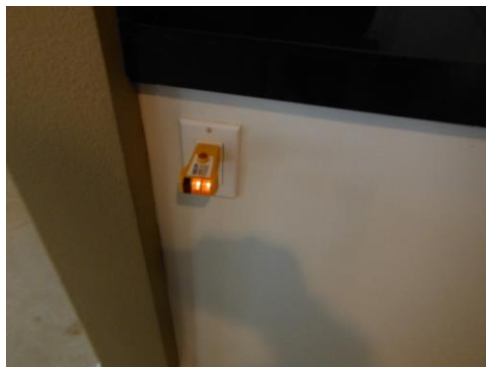
GFCI receptacles not installed at all places currently required. GFCI protection is missing at the kitchen island. We recommend adding these important life safety devices. Proper GFCI protection is especially important if young children will be present.

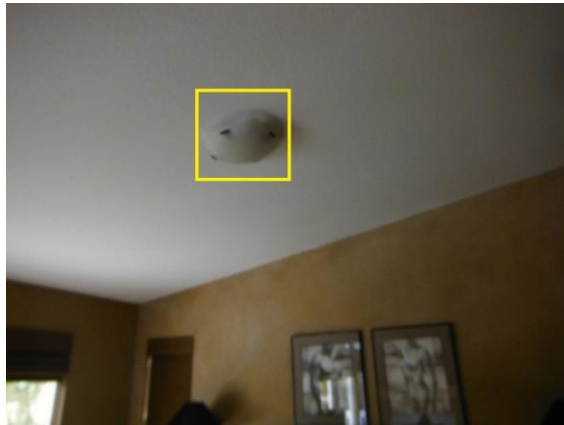
- * The master bedroom ceiling fixture.

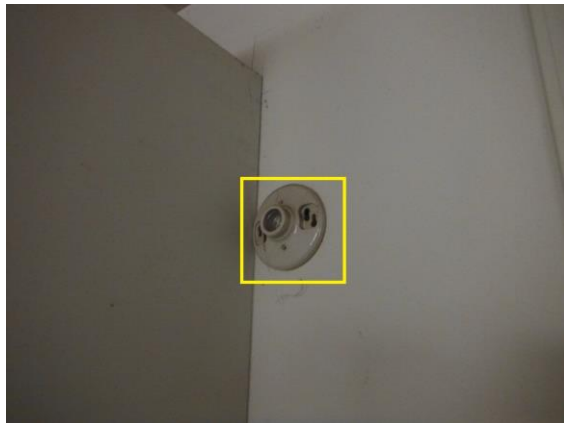
- * The garage light fixture; the bulb is missing.

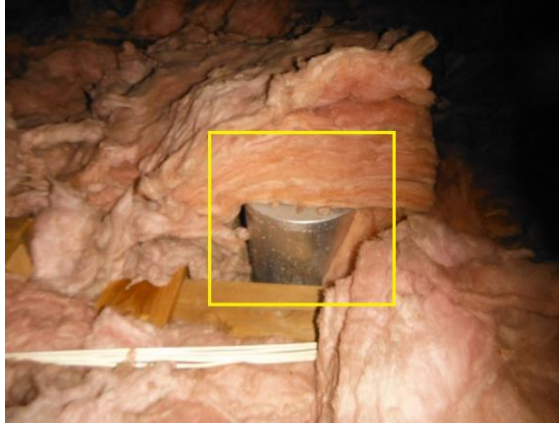
- The backsides of the recessed light fixtures in the attic are covered by/in contact with thermal insulation. Attic insulation in contact with most recessed light fixtures (unless rated "IC", in contact) can be a fire hazard. Recommend getting clearance where possible.

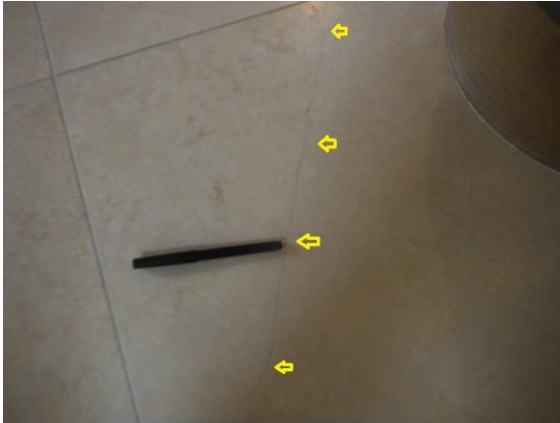
- We located a couple cracked floor tiles in the living room and kitchen. Conditions indicate that they are from impact damage, but we cannot categorically rule out, at least, an underlying drying shrinkage slab crack without removing the tile. All concrete cracks to some degree; some cracks are important, most are not.

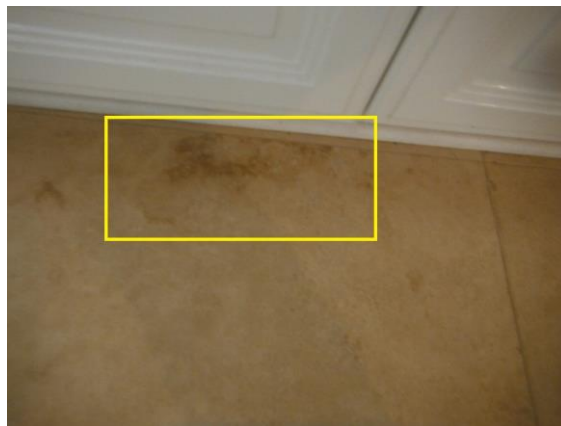
- The discoloration at the kitchen tile appear to be a stain from possibly a spill. Recommend asking the seller if they can provide further information.

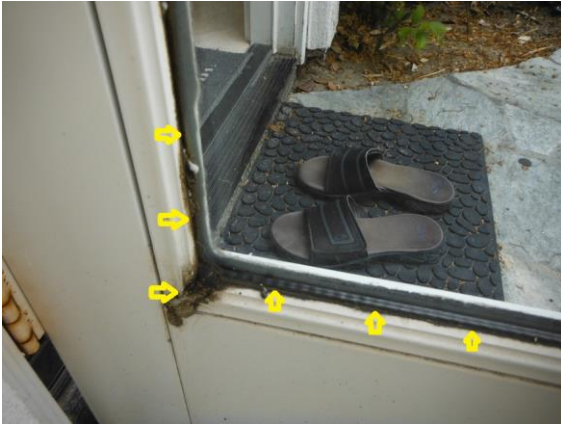
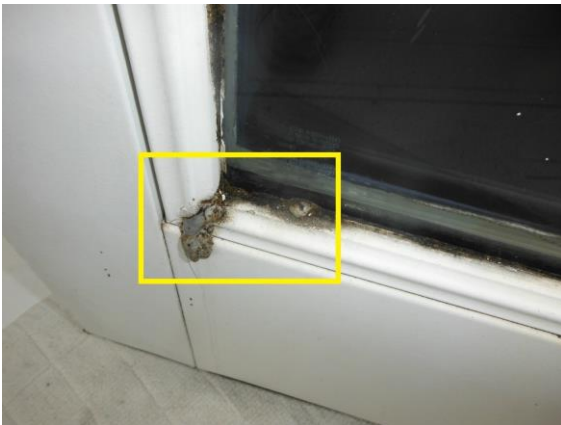
- There is excessive and unsightly sealant present at some of the exterior doors which contain thermopane glazing.

It's possible that the thermopane glazing was replaced in these doors and was not reinstalled well. Our concern is that water will be able to get behind the millwork/trim and eventually damage the doors.

Recommend asking seller if they can provide further information. If there was recent work on these doors, that contractor should return and make corrections or you should consult with a glazing or door/window specialty contractor for further guidance.

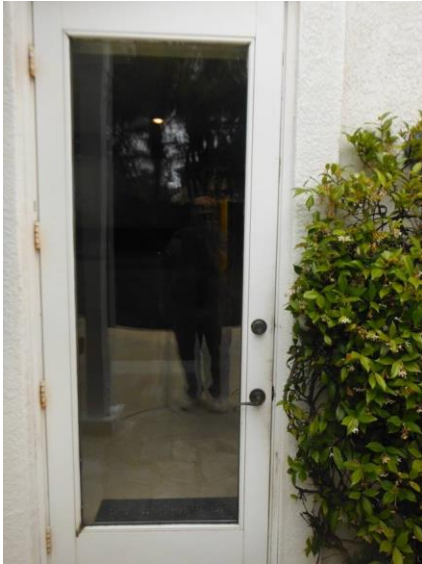
- The exterior door to the kitchen does not latch; you have to rely on the dead bolt.

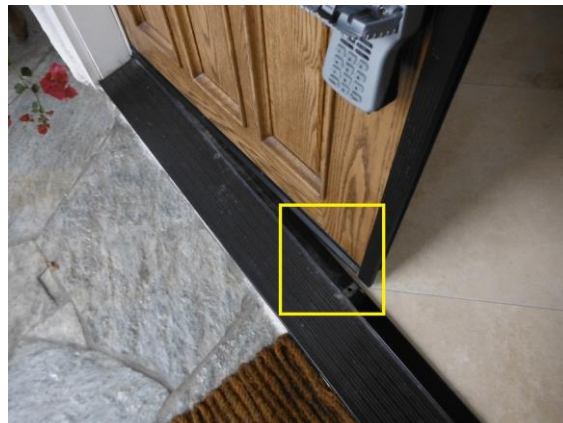
- The locking side front entry door rubs heavily; some minor misalignment.

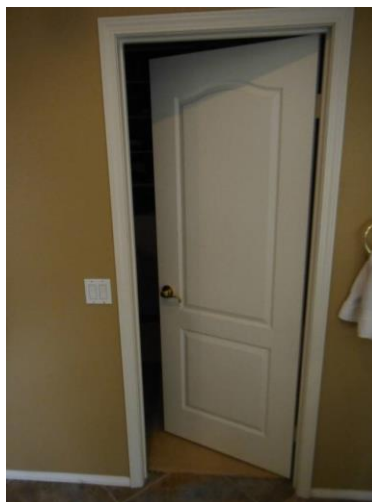
- The west door to the master bedroom closet does not latch; minor misalignment likely due to a loose upper hinge.

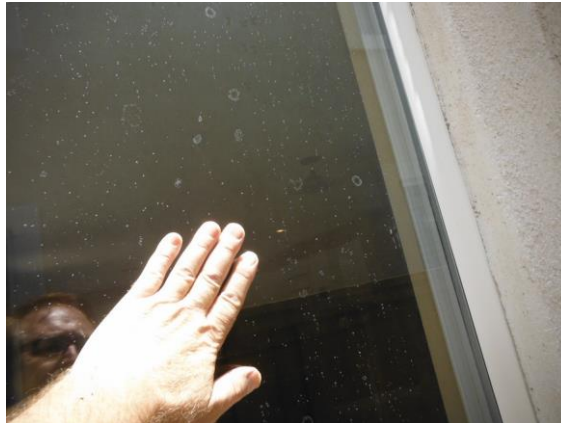
- There is some scratching of the door glazing, e.g., at the master bedroom door to the deck. Most likely the scratches are in the tinted film.

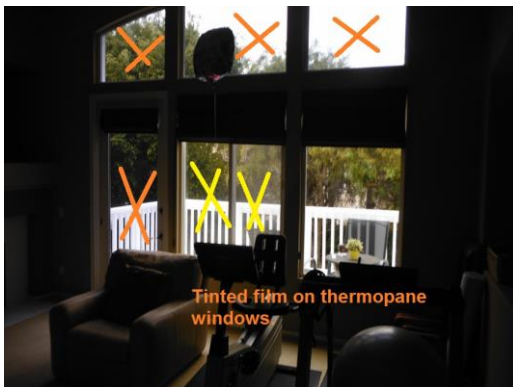
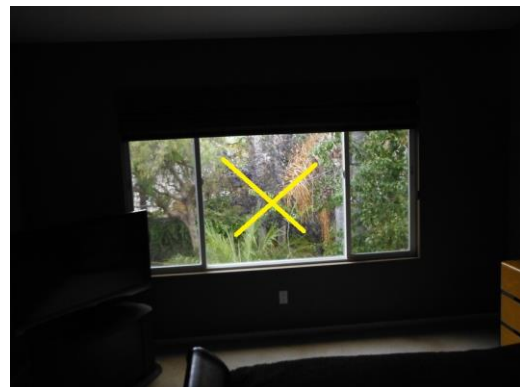
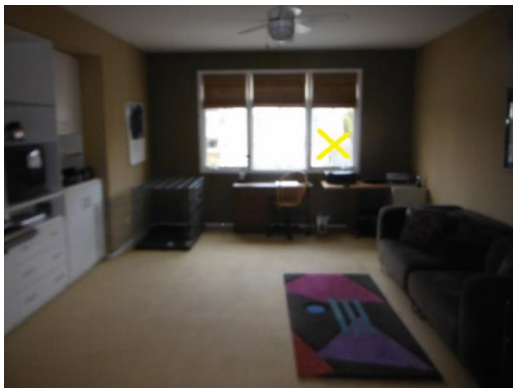
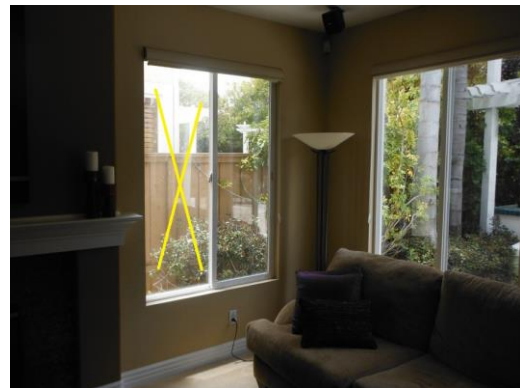
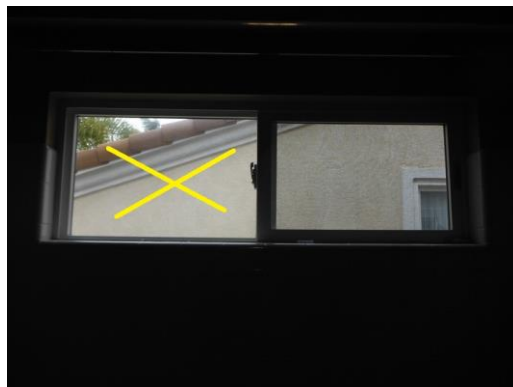
- At least, 6 thermal pane windows appear to show or are suspected to have leaking seals as manifested by glass that cannot be cleaned, is foggy and/or shows condensation between the panes.; includes but may not be limited to:

* Family room.

* Upstairs guest bathroom.

For any failed thermopane windows, the only correction is replacement of the sealed glass unit. Recommend that a qualified glazing contractor review the status of all thermal pane glazing to confirm its status and cost replacement before the release of contingency.

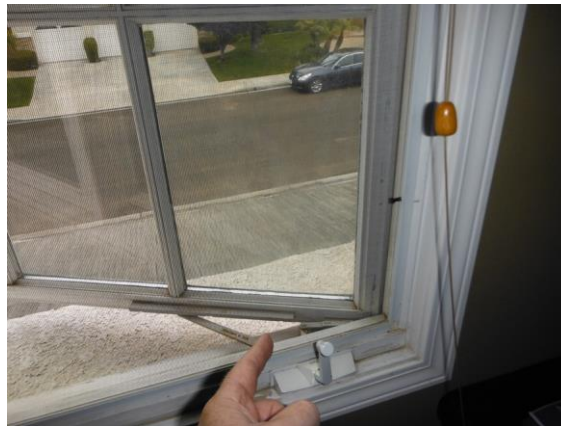
- We could not close the upstairs bonus room, right-hand window; the crank mechanism “slips”/ is not working correctly. Furth examination is needed to determine the exact correction/repair.

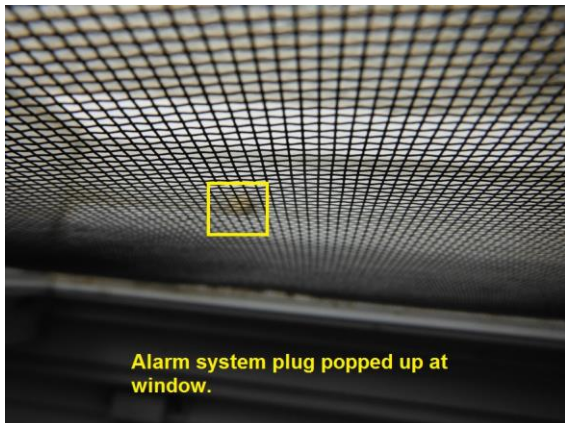
- There appears to be some alteration of window frames to accommodate a security system wires. Some of the plugs have actually popped up.

We cannot verify that these alterations are watertight. We recommend sealing/ caulking any holes/openings.

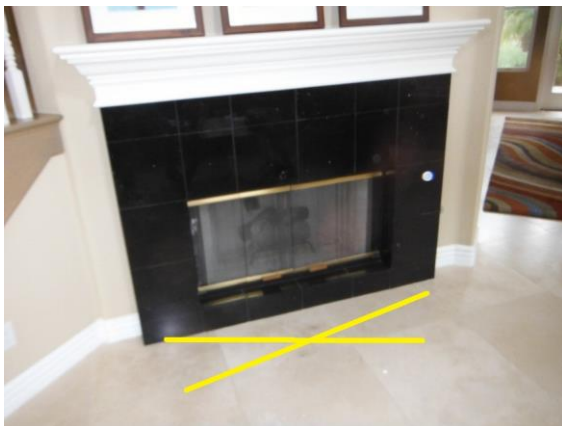
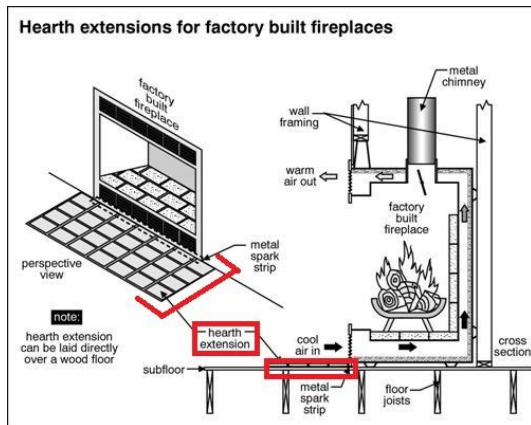
*** The hearth extensions have been removed likely during the aftermarket revision of the flooring around the fireplaces. Currently, there is no distinction between the hearth and flooring as required. This is a potential fire hazard because high heat can radiate to the floor immediately in front of the fireplace. Keep combustibles away from extension (area in front of fireplace) until corrected.**

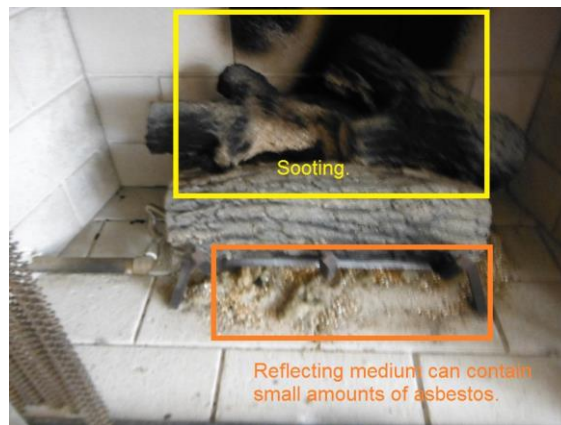
* The fireplaces show some sooting of the artificial logs and refractory panels. Sooting indicates incomplete gas combustion. One result of incomplete combustion is the formation of, at least, a small amount of carbon monoxide gas. Recommend the gas log set be examined to assure proper burn/combustion.

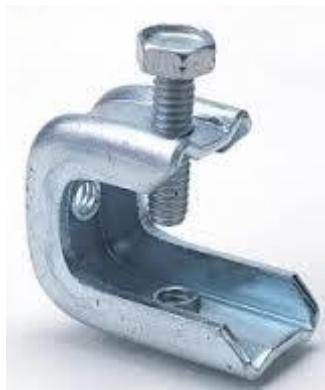
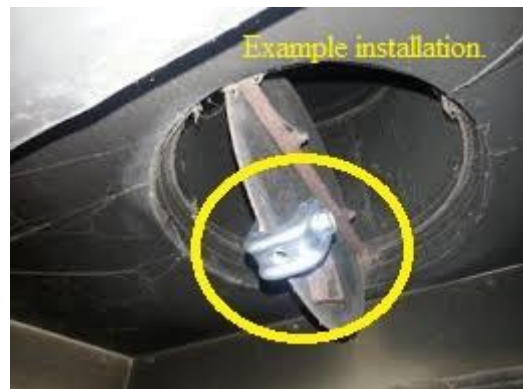
* **No clamps are installed at the dampers to keep them open as required since about 1994 when using an artificial gas log set. The clamp insures a constant source of combustion air for the gas-fired log set.**

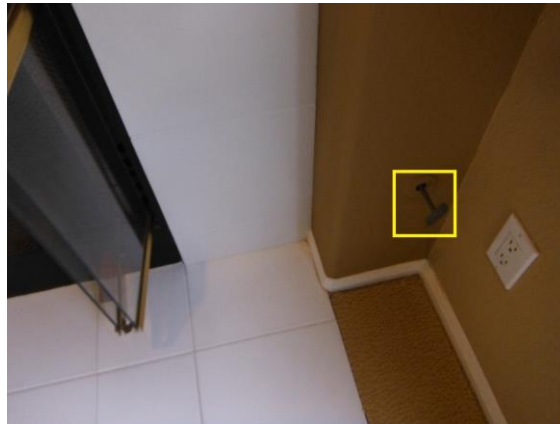
- There appears to be a gas “leak” (gas valve is open slightly in order to remove gas valve key) at the master bedroom fireplace.

We recommend further evaluation by a factory built fireplace specialty contractor in order to determine the exact correction/repair needed ideally before the release of contingency.

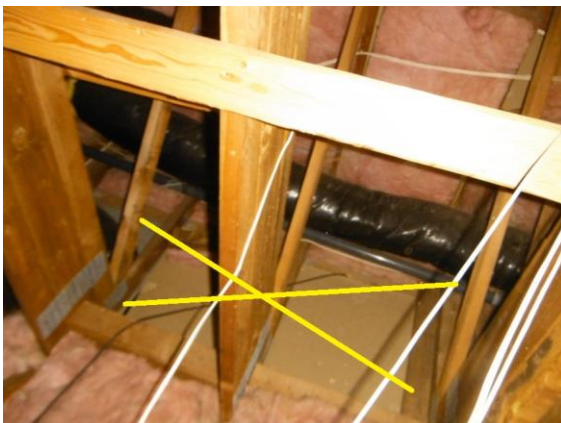
- A few insulation batts are out of place or missing.

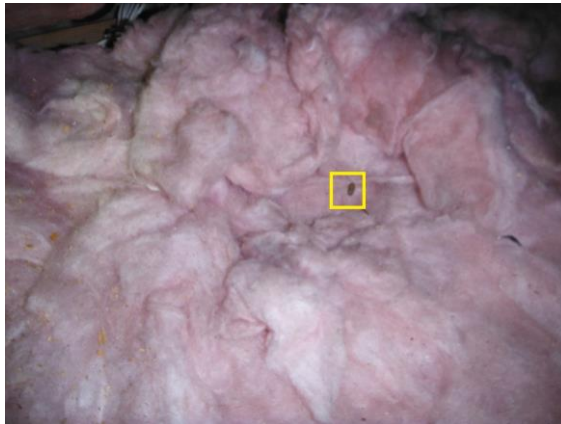
- There are some indicators rodent activity in the attic. While not observed, high activity can also damage to other systems (electrical wiring, air ducts etc.). Recommend consulting a licensed vector control contractor for further guidance.

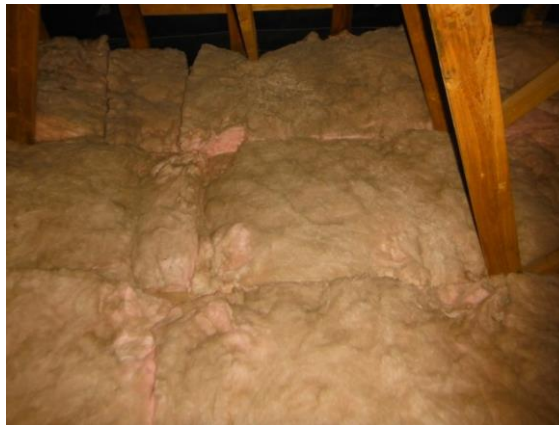
- As an advisory, some areas of insulation are covered with what appears to be a light dusting of ash from past wild fires.

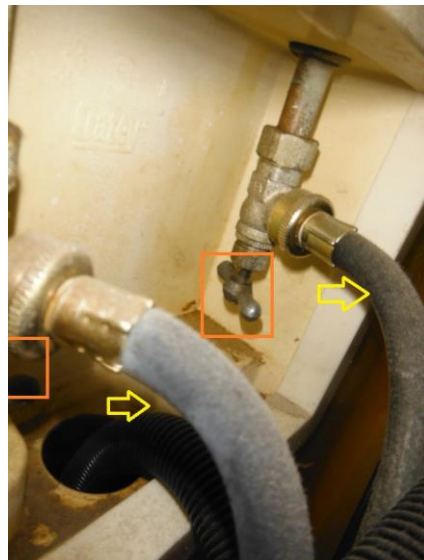
- **Water supply connectors serving clothes washer are made of rubber. As these eventually fail, recommend replacing with braided, stainless steel connectors.**

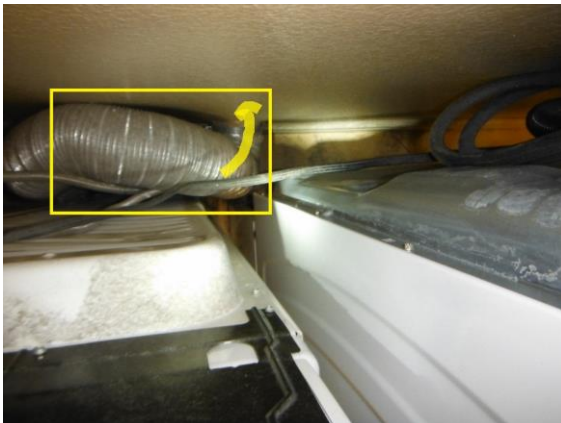
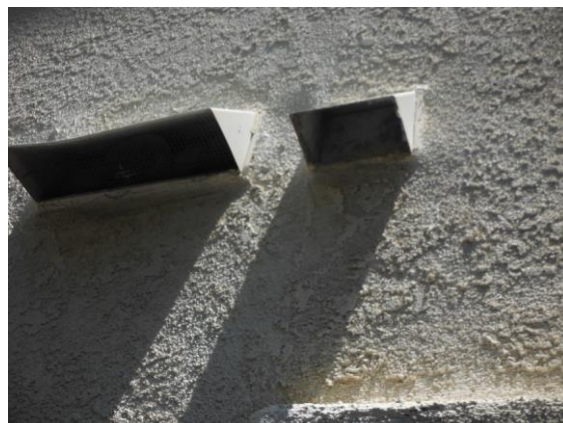
- **The clothes dryer duct to the exterior appears to exceed length limitations. A dryer vent cannot exceed 14 feet in total length when 2, 90 degree bends are involved. Recommend periodic cleaning of the lint from the duct for fire safety and dryer efficiency.**

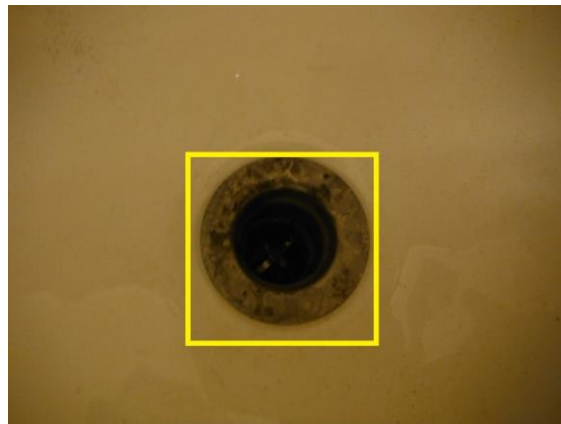
- The sink drain is corroded somewhat.

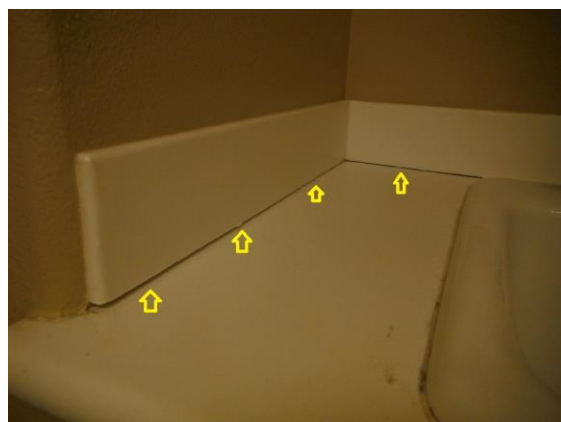
- The sink countertop and separated/sags from the backsplash somewhat.

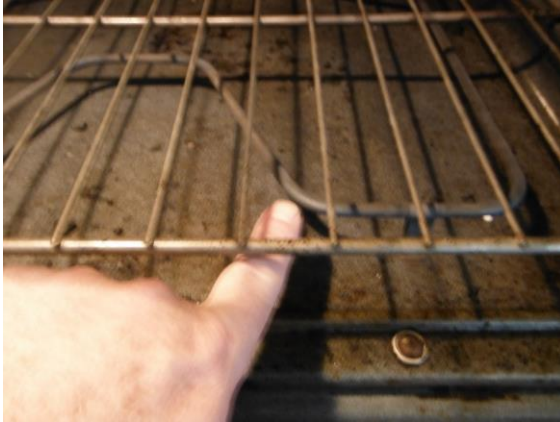
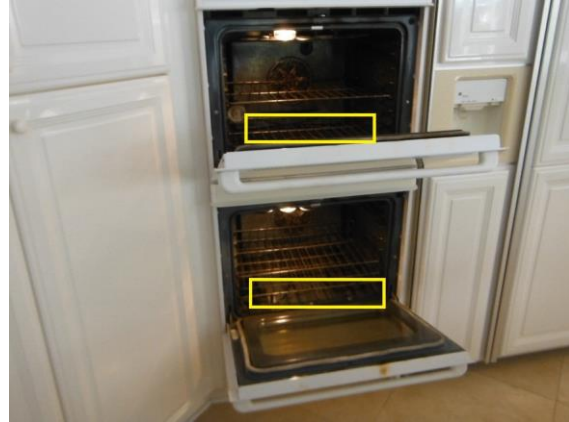
- The lower heating elements in both ovens (bake mode) could not be made to work. The elements may not be set properly. We recommend, at least, getting a satisfactory demonstration. An appliance contractor service call may be warranted.

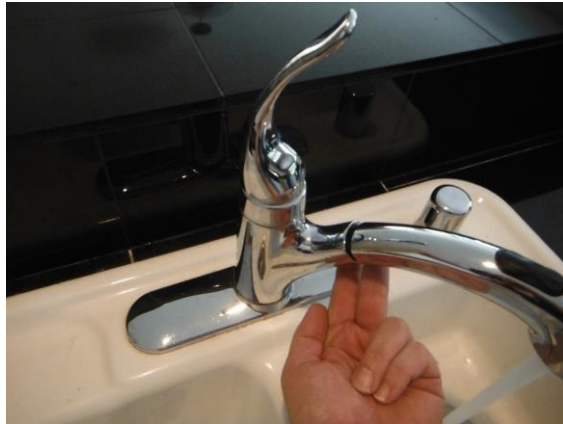
- The faucet fixture swivels with difficulty; we did not force it. This condition suggests a deteriorated/worn out fixture which can eventually lead to leakage and under cabinet water damage if you try to free up fixture movement. **It may be more cost efficient to replace the faucet than try to repair it**

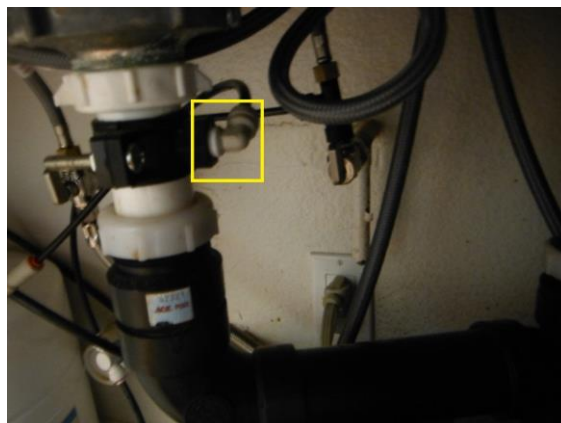
Also, the discharge piping for the filter system is connected to the undersink waste piping.

Technically, this is a prohibited cross connection between grey and potable water and is not allowed. Recommend creating an air gap to eliminate this potentially unsanitary condition. A licensed plumber who has experience with reverse osmosis systems may be able to make recommendations for correction.
