Lorber Engineers

RE: Home Inspection
12345 XXXX St
San Diego, CA 92130

As you requested, we completed a limited structural and mechanical inspection of the above property on June XX, 201XX. This report presents the results of that inspection.

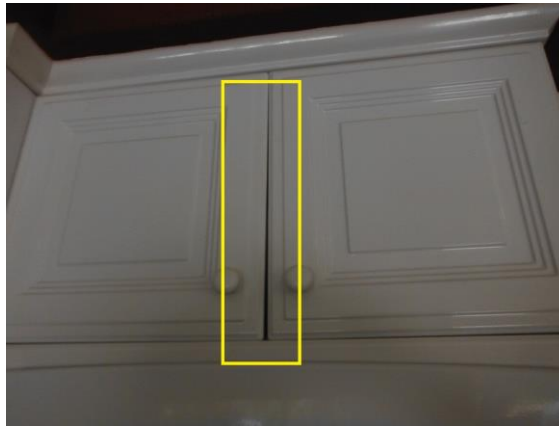
- There is some minor cabinet door misalignment.

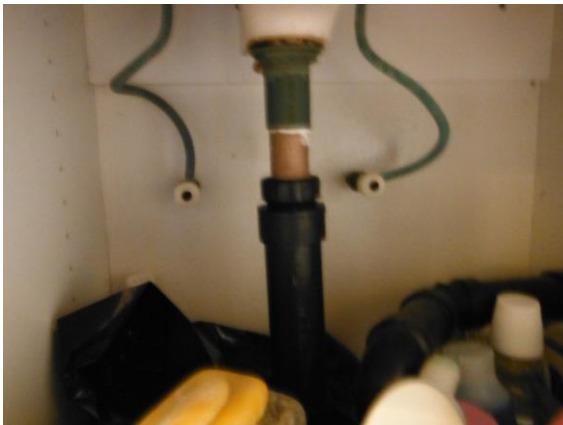
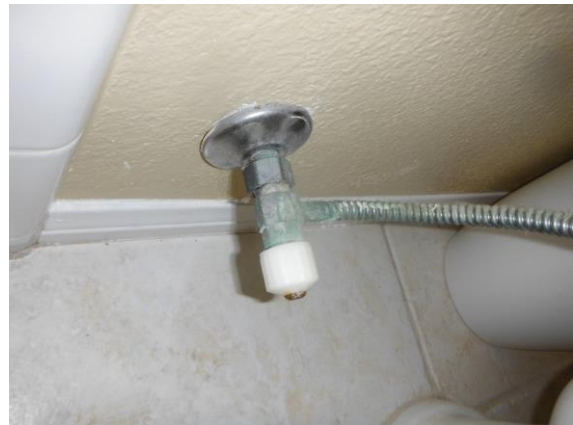
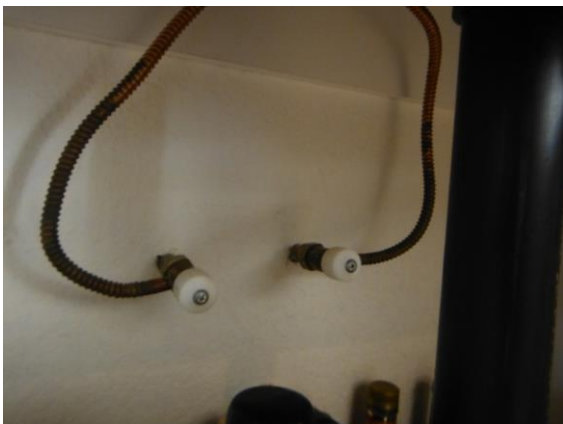
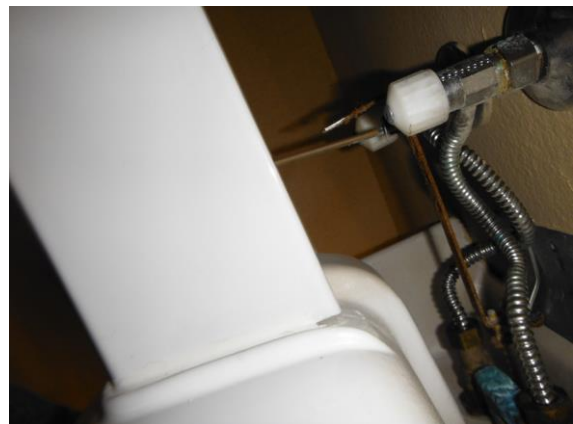
- Most of the water supply shutoff valves have plastic valve stems can which become unreliable with age **including at the laundry, wet bar and kitchen sinks**. A failed shut-off valve can lead to extensive flooding/damage. **As an improvement, we recommend replacing the shutoff valves at your earliest convenience.**

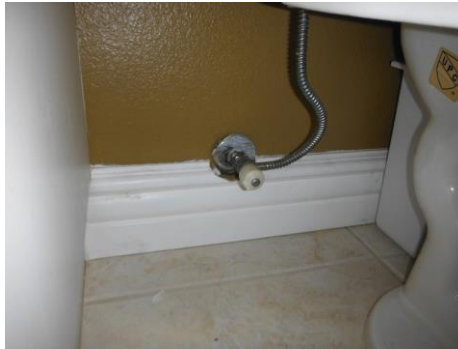
Most of the flexible, metal water supply connectors serving the plumbing fixtures are obsolete. A failed water connector can lead to extensive flooding/damage. **As an improvement, recommend replacing the obsolete connectors with braided stainless steel connections which are far less prone to fail over time.**

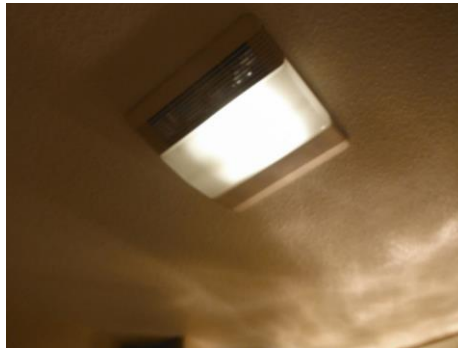
- Some Nutone brand fans appears to be installed. Nutone exhaust fan/light fixtures made between 1996 & 1997 have been recalled. A wiring defect can lead to a shock hazard when changing light bulbs.

We have no way to confirm if this is one of the recalled models without disassembly to acquire the model/serial number. The CPSC (consumer product safety commission) website has detailed information about the fan recall.

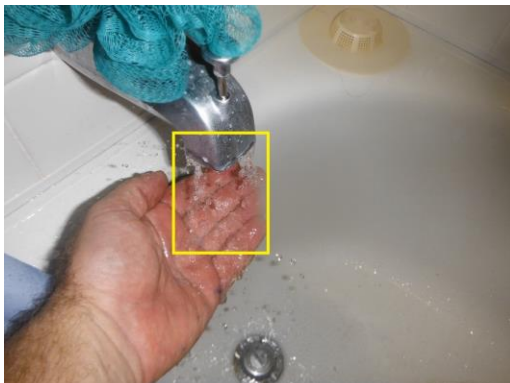
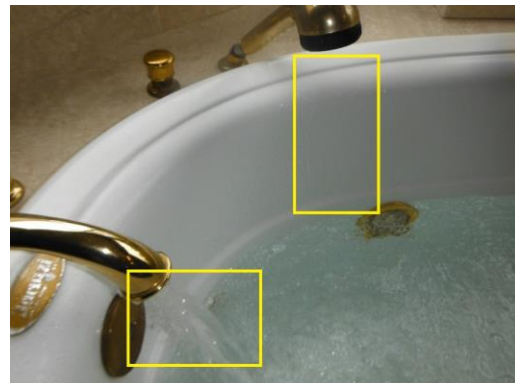
- The tub-to-shower or to- spray head diverter valves work inefficiently; these valves can readily be replaced

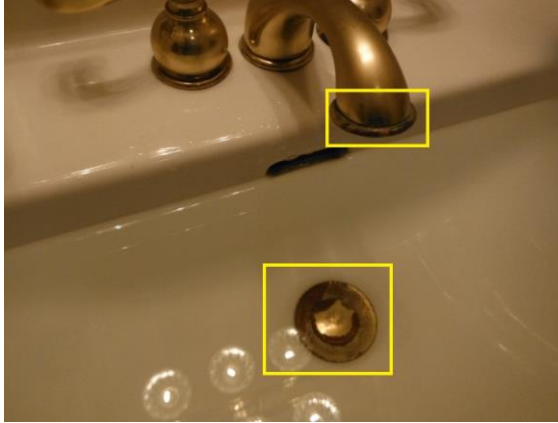
- There is general discoloration and corrosion of plumbing fixtures.

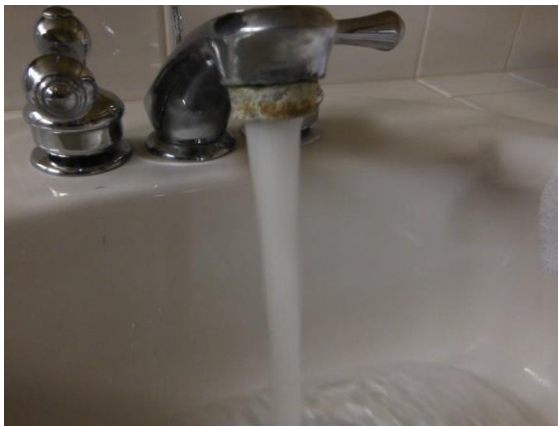
- There is some mineral build-up on the fixtures and shutoff valves with some diminished flow at fixtures. You may want to consider adding a water softener to help reduce the accumulation of the salts, reduce fixture maintenance and improve performance.

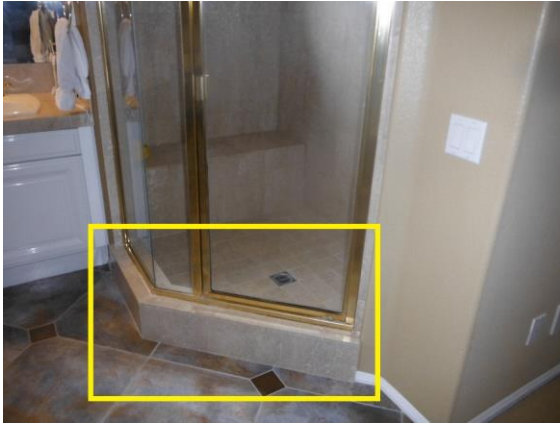
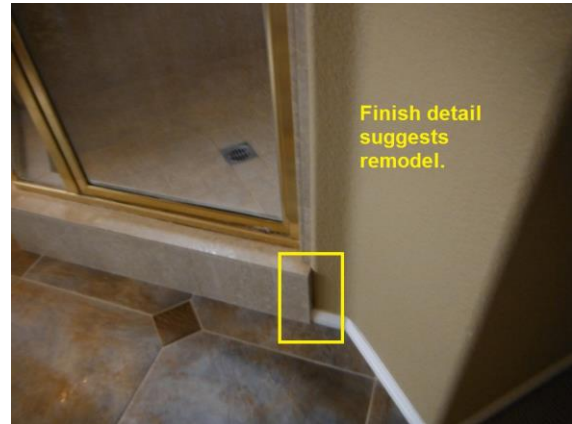
- This bathroom appears to show some revisions – mostly tile work; there may be work invoices/warranties available.
- It's likely that the tile shower enclosure is not the original

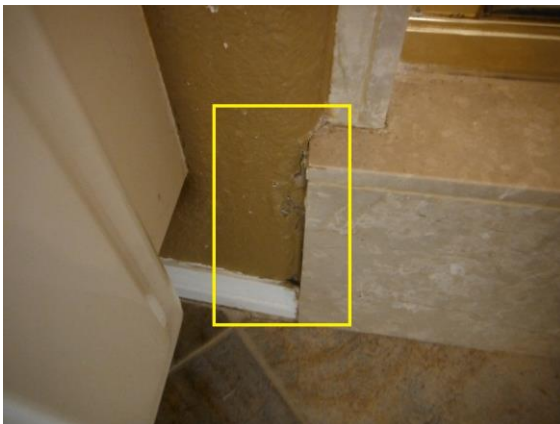
- There is minor spot drywall damage and slightly elevated moisture readings (17%) on the lower exterior wall at the shower.

The “leak mechanism(s)” or elevated moisture readings cannot be definitively known in the course of a home inspection; there are various possible causes.

Further examination would be required to determine exact problem(s). You cannot assume that any water exfiltration is solved by caulking the shower door metal frame.

We cannot categorically rule out the backing up of water under the tiles and outside of the shower enclosure because of clogged shower drain weep holes. If this work is still within a warranty period, we recommend that the contractor review this condition and comment. Otherwise, as a precaution, we recommend that a qualified plumber examine the drain weep holes to ensure that they are not clogged.

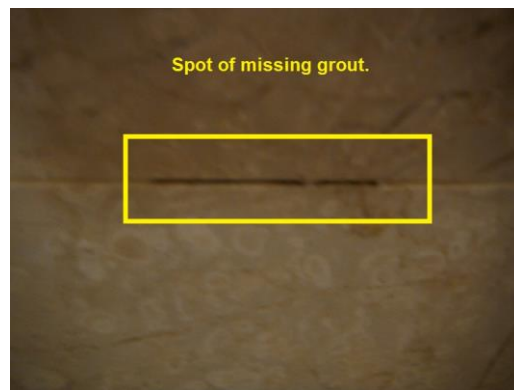
- There are a couple spots where tile grout is missing.

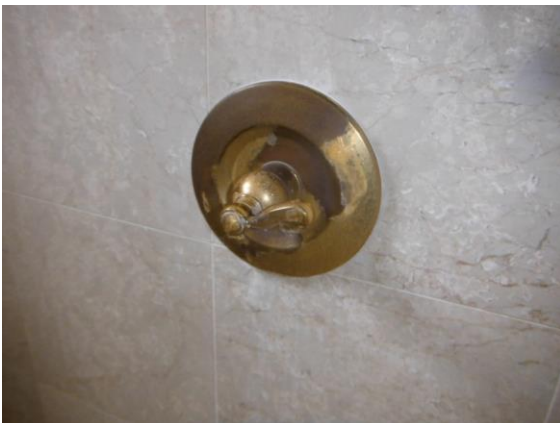
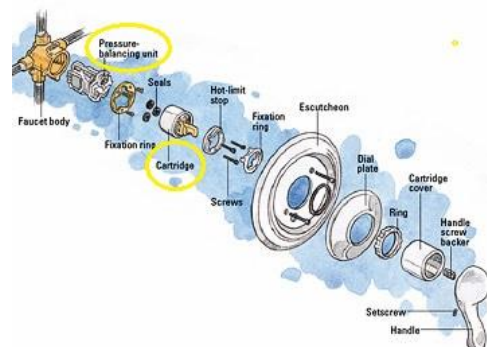
- **You can never fully get cold water at the mono water control handle. While of minor consequence at this point in time because you normally want more than cold water in a shower, difficulty regulating temperature can indicate a problem with the cartridge and/or pressure balance valve. We recommend further evaluation to determine the exact condition.**

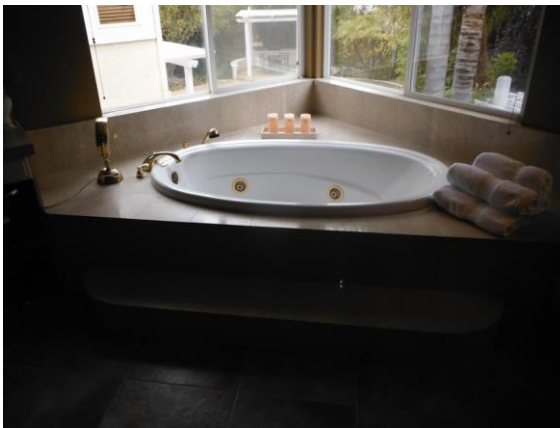
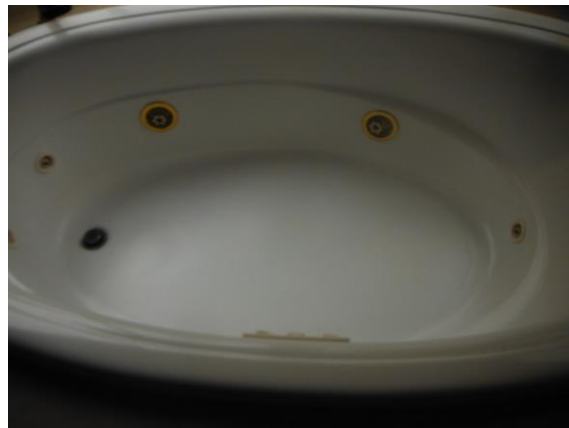
- The whirlpool tub pump is operational; only brief operational test. Recommend getting extended demonstration, including all jet settings/features prior to the close of escrow

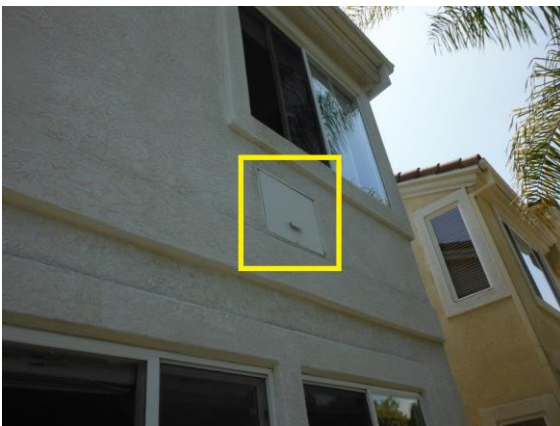
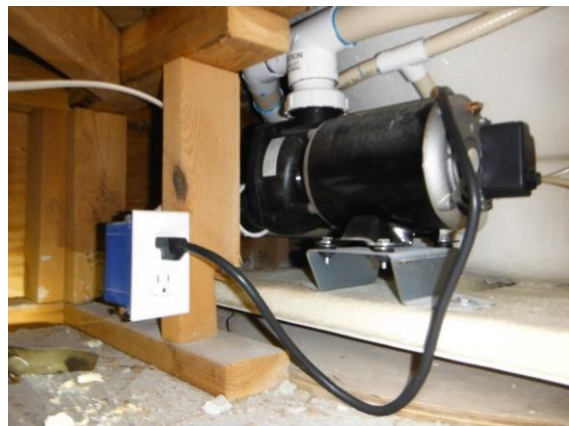
- As an advisory, any whirlpool tub piping can harbor bacteria. Recommend disinfecting before use and then periodically.
- The pump access is located on the exterior.

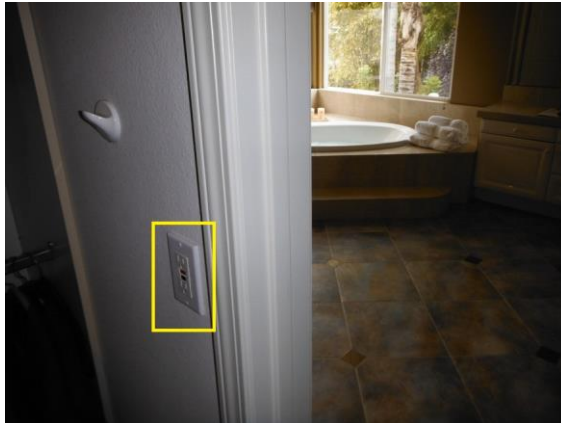
- As an advisory, the GFCI that protects the whirlpool tub pump electrical circuit is located in the closet.

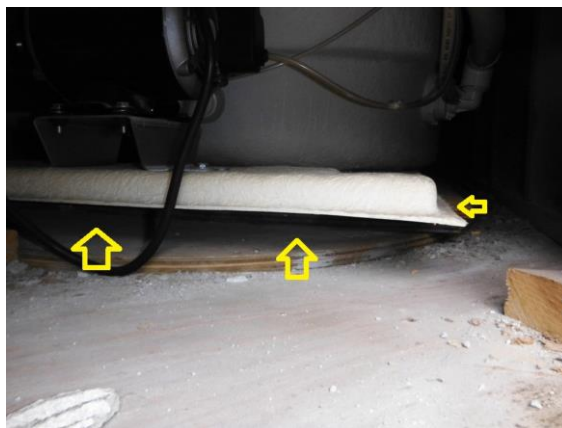
- As an advisory, the tub bottom is supported plywood and not on a mortar bed as generally specified by the tub manufactures. A full mortar bed or equivalent is better able to resist sagging, defection, water damage etc.

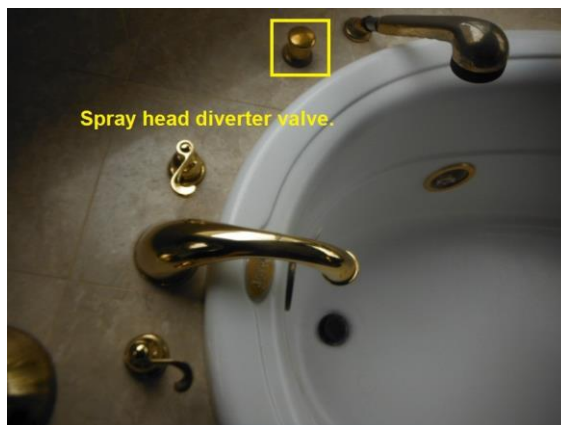
- The tub faucet-to-spray head diverter valve diverted to the spray head on its own when running the faucet. This may indicate lack of use or some other shortcoming with the diverter valve. Ask seller if they can provide further information; if they were experiencing any problems.

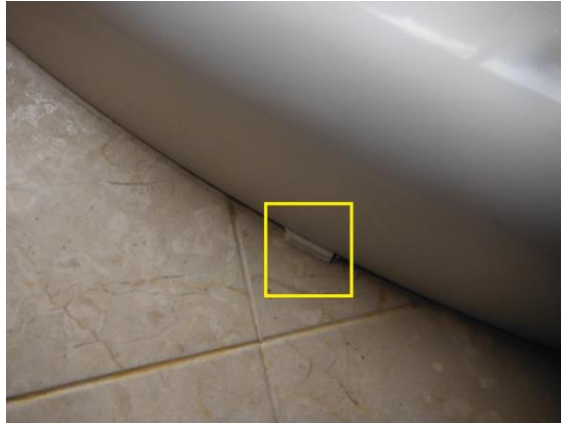
- We noted what appears to be a shim on the edge of the tub. Possibly indicates that sealant is missing.

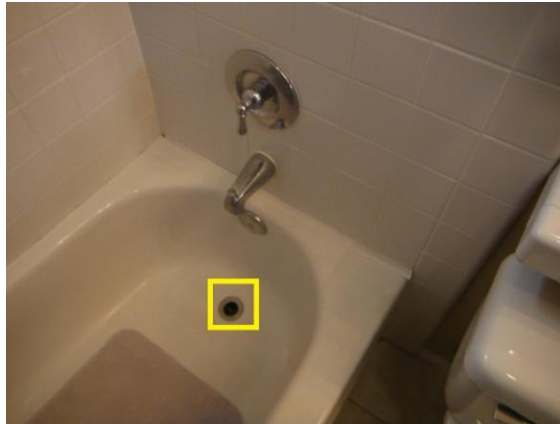
-The tub drain plug is not installed likely because it does not work; recommend replacing it.

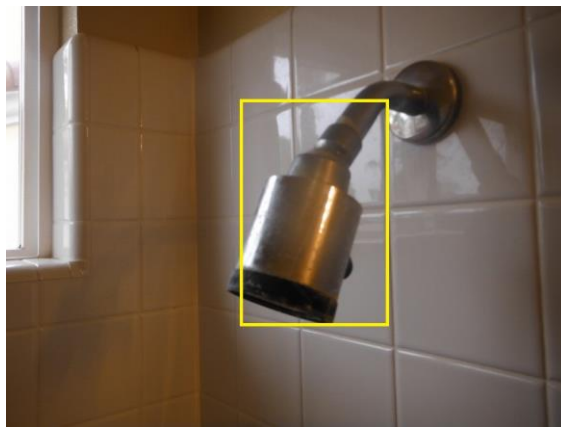
- The shower head is “frozen” tight; cannot be adjusted.

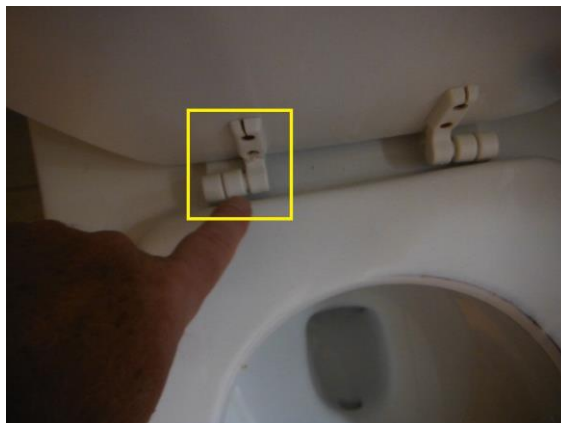
- The toilet seat is damaged on the left-hand side. We recommend replacing the cover.

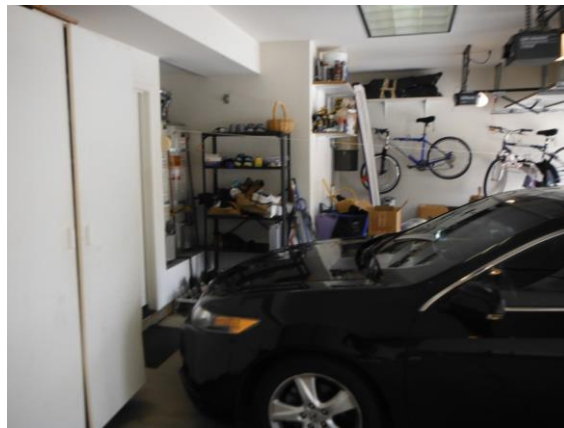
- Many surfaces are obscured by storage materials, vehicle, equipment etc. Recommend review of all obscured walls and features once garage is emptied.

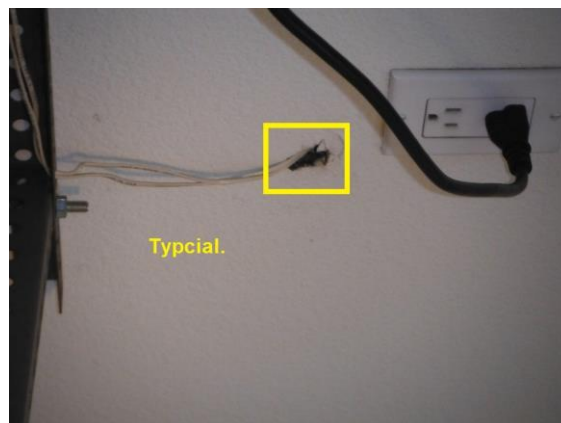
- A few miscellaneous small holes/openings need to be sealed for fire safety.

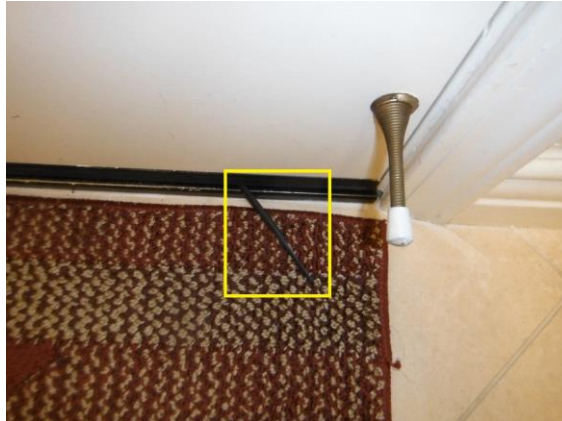
- The door gasket/seal is partly damaged. Any gaps around part of the door when closed can allow a fire to readily draft into the home.

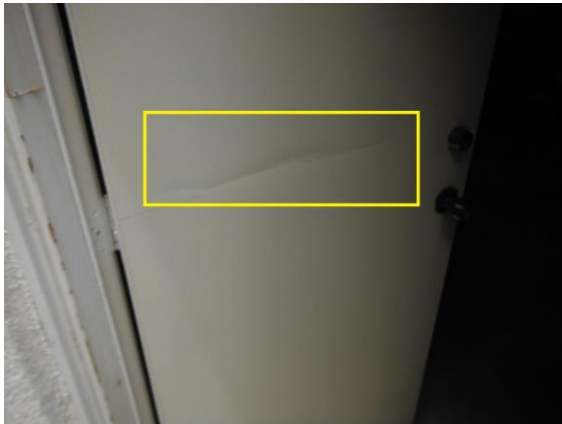
- There is some minor impact damage, possibly caused by a pet.

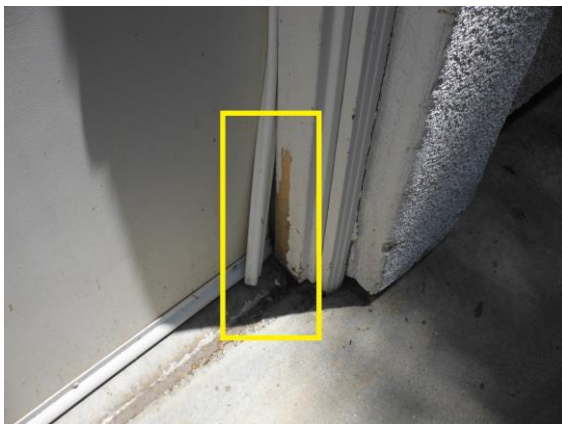
- The door weather stripping and wood trim shows minor damage likely caused by a pet.

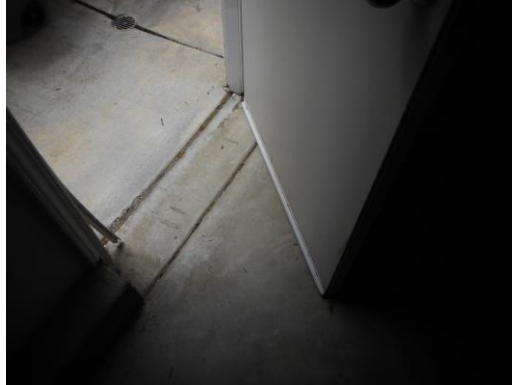
- While common, no door threshold is installed; can allow rodent ingress.

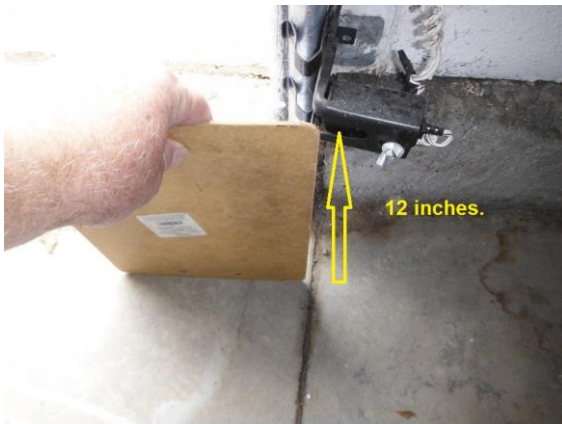
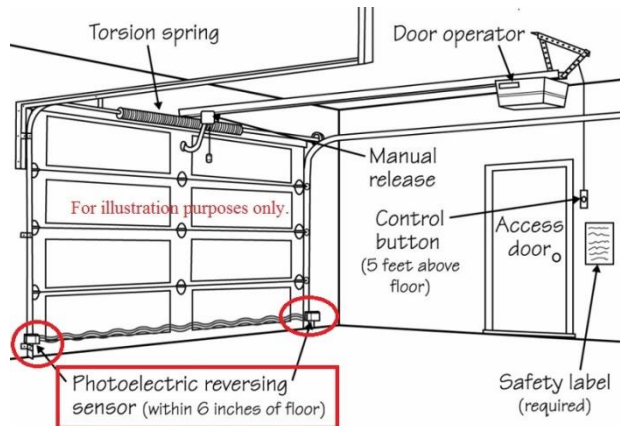
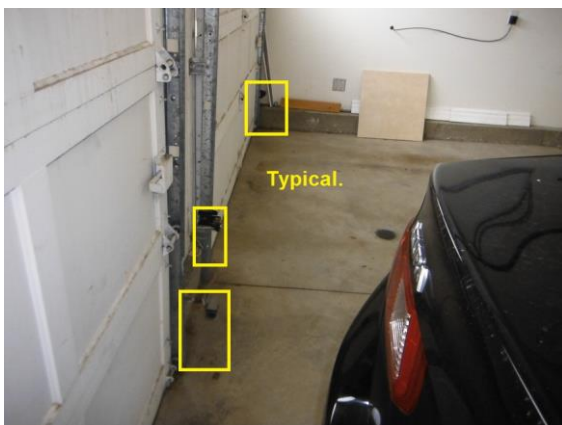
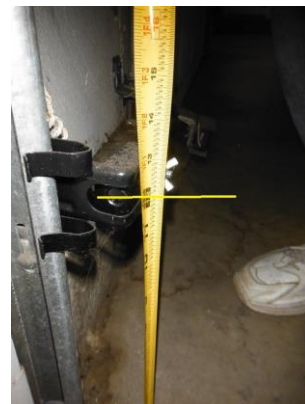
- All (3) sets of photo electric eyes for auto reverse mechanisms are set way too high – about 12 inches off the slab; required to be set no higher than 6 inches above the garage slab for safety.

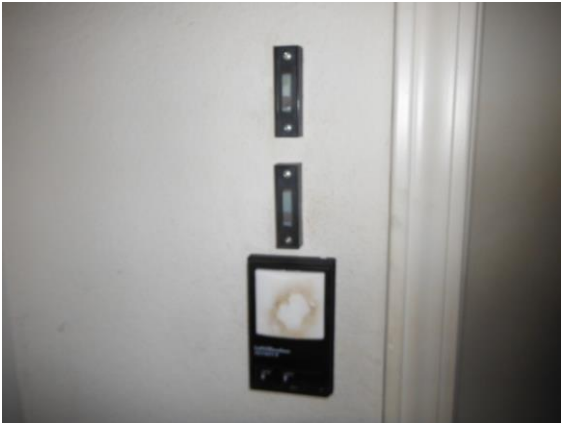
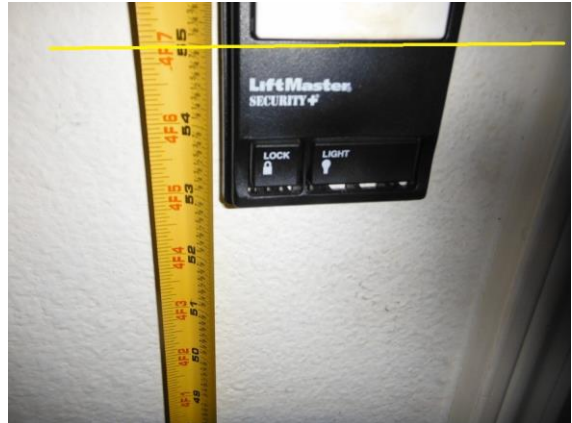
- The electric opener control buttons are not set high enough above the floor and can be operated by small children. Minimum height for all control buttons is 60 inches.

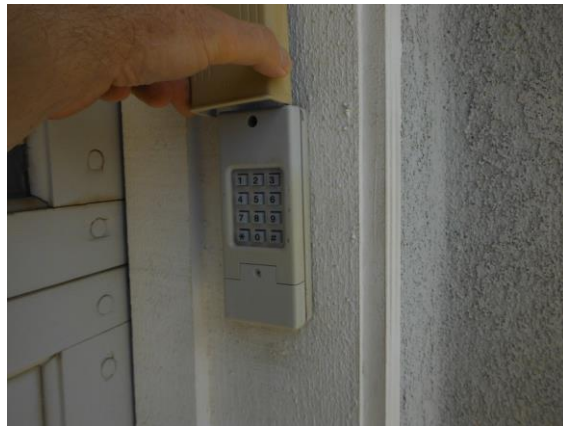
- The overhead door opener "touch" pad was not tested. Recommend getting a satisfactory demonstration prior to close of escrow.

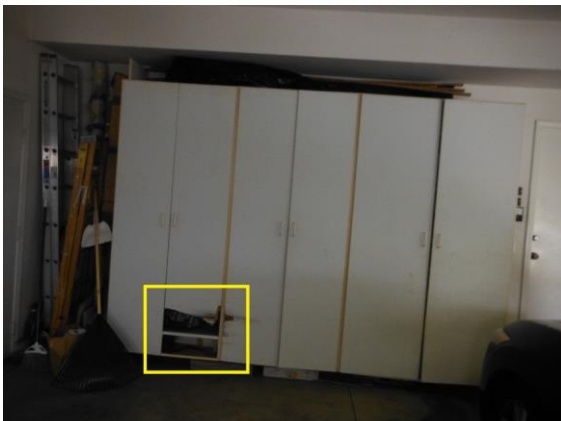
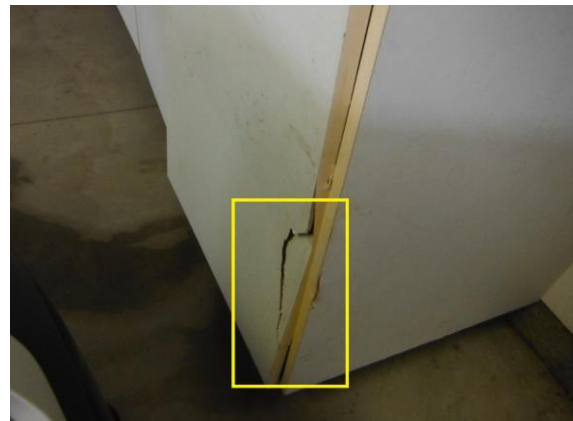
- There is some impact damage to the cabinets.

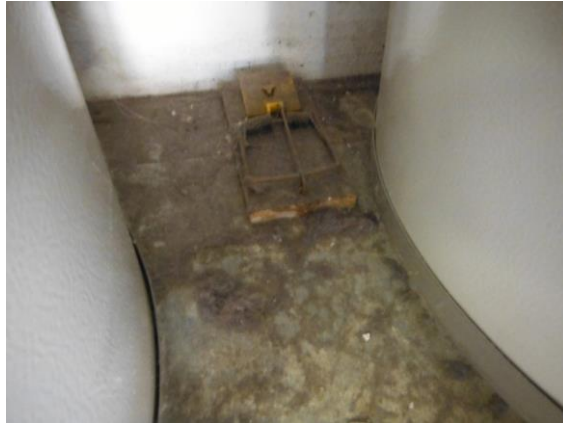
- There are some indicators rodent activity. Recommend consulting a licensed vector control contractor for further guidance.
